PROJECT SERVICE RESERVOIR ASBESTOS REMOVAL

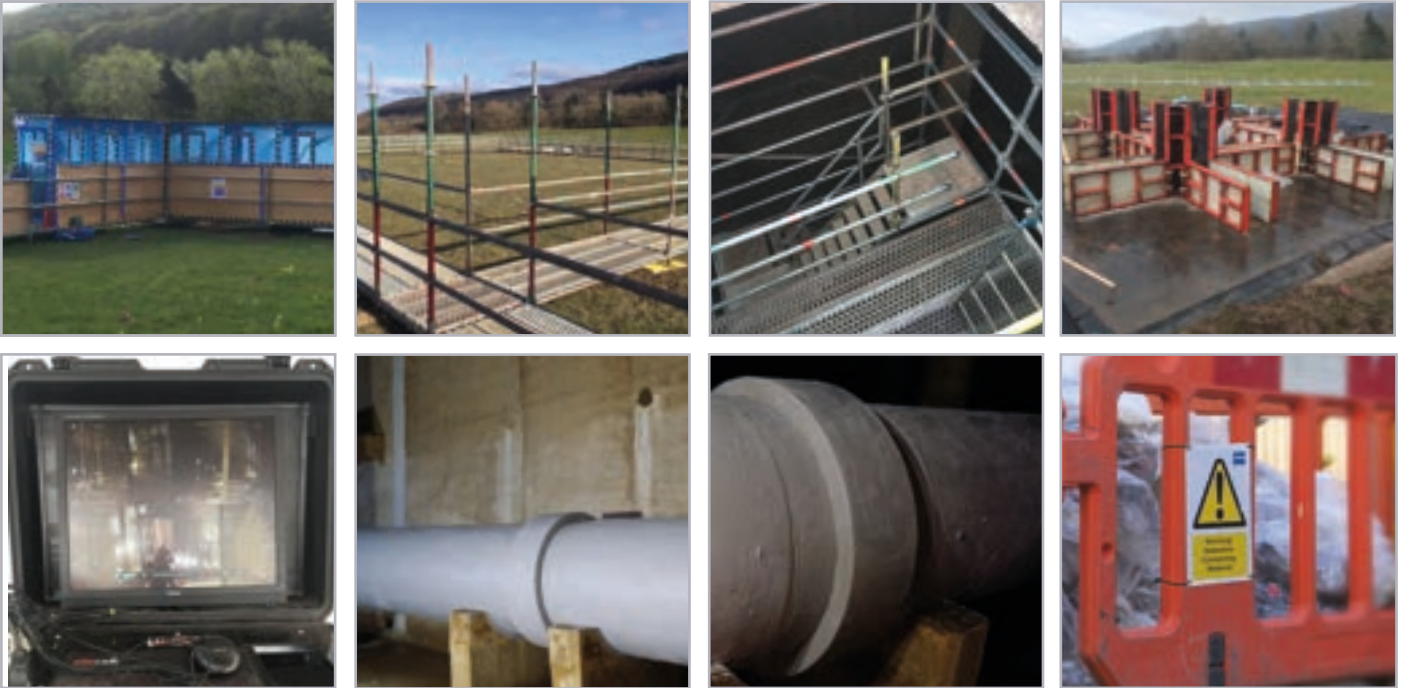
Stonbury were contracted by a framework client to return to a service reservoir that was initially taken out of service several years ago, after an inspection highlighted asbestos fibre contamination, due to a delaminating asbestos cement inlet main.

A full asbestos clean of the reservoir was undertaken, followed by encapsulation of the inlet main in its entirety, using MasterSeal 933, a DWI Regulation 31 approved product. The application was strictly monitored and all application and curing data recorded.
