PROJECT OUTFALL STRUCTURE REPAIRS

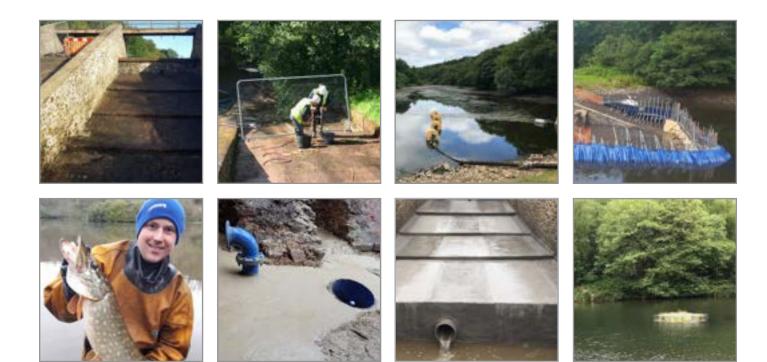
Stonbury was contracted to carry out comprehensive repairs to an existing outfall structure situated on a lake in the South West. The original scope of works involved desilting around the outfall pipework, however, following an investigation, deep voids were identified within the dam structure.

Due to the depth of some of the voids, it was agreed with the client that repairs would include grouting and sprayed concrete application. Steel mesh reinforcement was fixed into place, and short lengths of pipe were installed into the wall at selected positions. Concrete was then sprayed onto the mesh to the required thickness. Following the curing period, grout was pumped through the pipes into the voids behind the walls. Once complete, the short sections of pipe were broken out and the concrete repaired. The large voids at the top of the dam structure were also filled, using a pumpable grout.
