PROJECT WWTW TANK REPAIRS

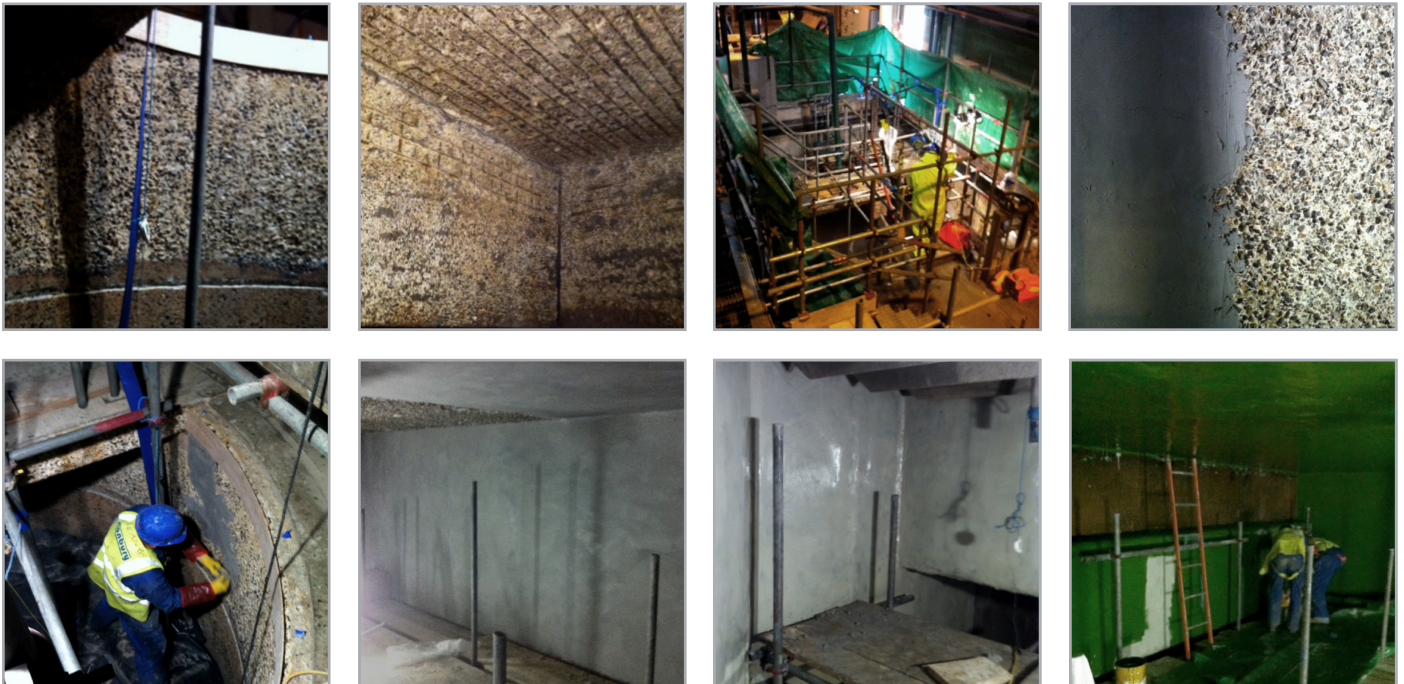
Chemical attack had caused severe erosion to the substrate, with a loss of coverage recorded as low as 60mm in some areas. A survey was completed to assess the full extent of the damage to the tanks, using both intrusive and non-destructive testing techniques, which included; impulse radar, dynamic impedance and targeted coring. As the plant remained fully operational at this stage, manned entry was avoided, the investigation was conducted externally using accessible surfaces of the tanks.

High-pressure water jetting was used on all surfaces, to remove any loose material and debris build up from the walls and soffit. An adhesive repair mortar was then applied to the surfaces, in 15-20mm stages, providing a chemical resistant and water tolerant coating. Once cured, two coats of epoxy resin were applied for additional resistance against future chemical attack.
