PROJECT INTERNAL & EXTERNAL RESERVOIR REFURBISHMENT

Stonbury completed refurbishment works to extend the life of a 40ML underground service reservoir which indicated signs of severe ingress from rainwater.

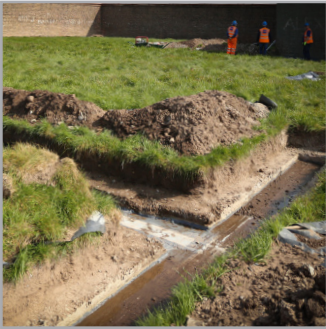
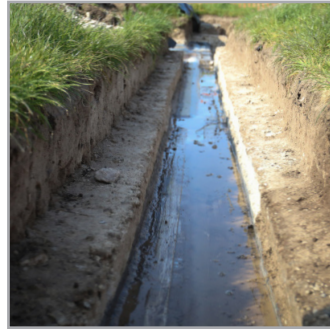
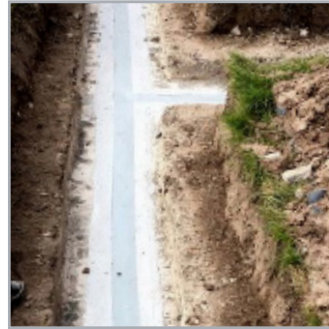
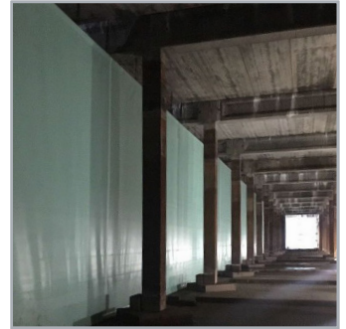
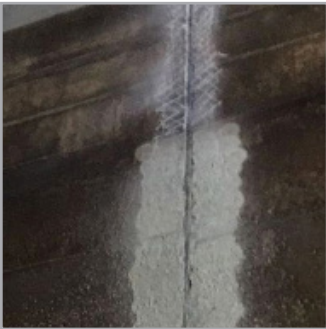
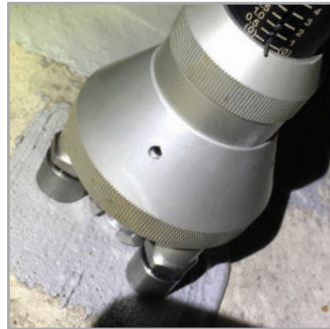
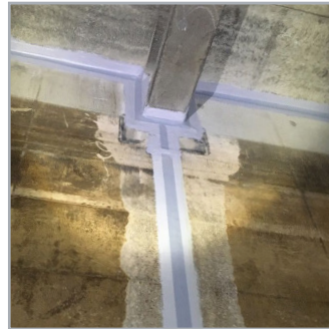
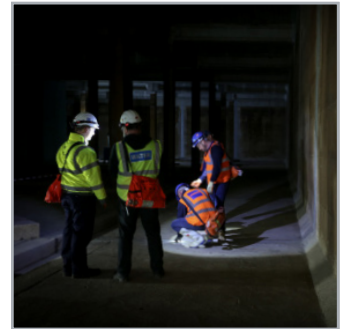
The scope involved the complete excavation of the roof and the top screed layer, to expose the roof joints where the sealant had deteriorated. This was carried out by hand to avoid the potential contamination from diesel-powered equipment on the roofs of clean water reservoirs.

Following preparation of the roof joints, an epoxy resin adhesive was applied using brushes, followed by the installation of waterproofing bandage. Subsequently, flood testing highlighted water ingress in previously dry areas, which significantly increased the area of repair. The external repairs were completed with the application of liquid plastic, to encapsulate the reinstated joints.

Inside the reservoir, surface preparation was carried out on the walls and soffit and pull-off tests were conducted to ensure sufficient adhesion to the substrate. Epoxy resin and waterproofing bandage were then applied to the internal wall joints, beam ends and areas along the roof. Detailed application and curing records were maintained throughout, and data-logging equipment recorded the exact temperature within the tank.

The scope also included the removal of the existing handrail and baffle curtain, which was made up of plastic corrugated sheeting and fixed into place on a badly corroded steel frame. A new thermoplastic curtain was installed, along with a new stainless-steel handrail to ensure safe access and egress for future maintenance and testing.
