## PROJECT UPSTAND SCHEME

**Stonbury recently completed a scheme of works to provide greater resilience against future bacteriological failures. The scheme included the coating of over 300 upstands for a framework client, where a fast turnaround of was required.**

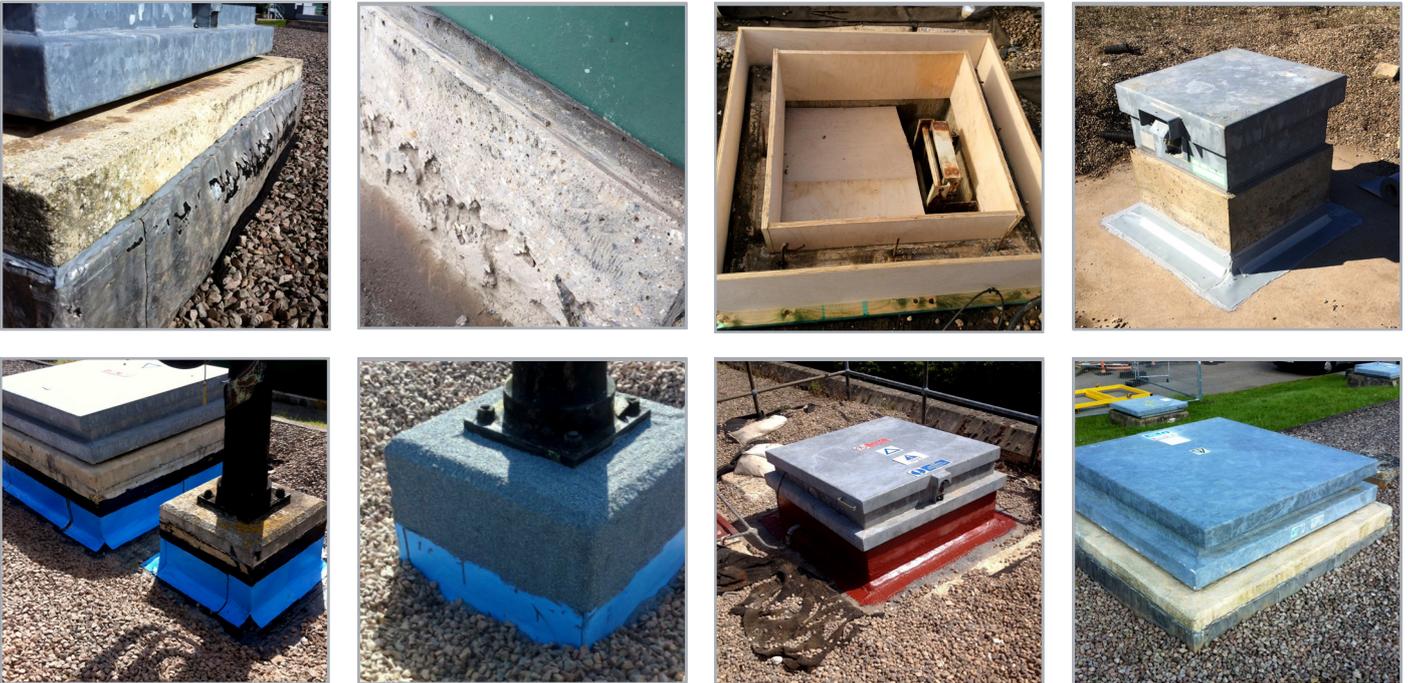
Under the scope of works, all upstands situated over or in contact with potable water were to receive a new waterproof membrane, using approved waterproofing systems. Excavation work varied across each site, however most tanks did require a complete dig out and removal before works could begin. The scheme required working with both gravel and soil topped sites.

Preparation work involved the removal of any existing defective coatings, followed by a high-pressure water jet to eradicate build-up of laitance and debris. Each upstand was then primed before a new waterproof membrane was applied, this would reseal the structure and safeguard against future water ingress.

Working to the required specification, Natcem fillets were installed to remove all 90° angles, avoiding any future damage from sharp edges. Over banding was also applied to seal the roof to the upstand joint offering additional protection against ingress.

A liquid membrane was applied to each upstand and finished with the application of UV Stable granules. On completion of each site, all gravel and soil were reinstated and finally handed back for sign off. Works were completed in good time and finished to an excellent standard, under ideal weather conditions.
