Stonbury was contracted to deliver repairs to a spillway in Lancashire after the existing gabion baskets supporting the structure had degraded.

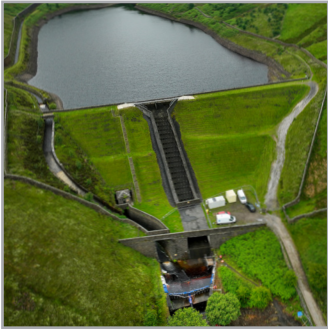
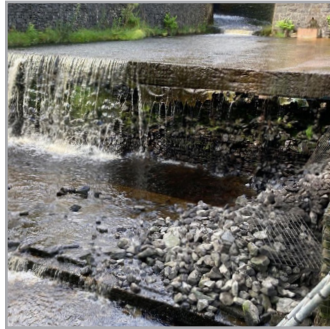
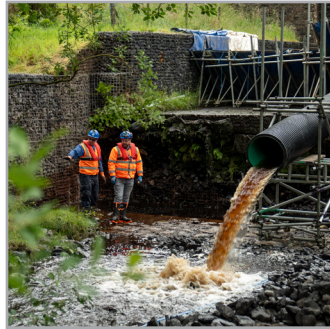
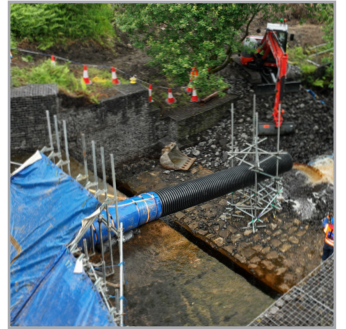
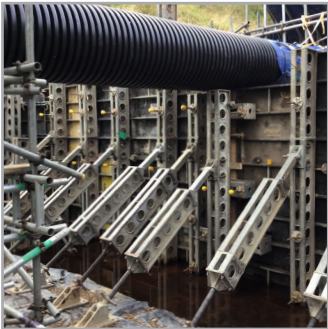
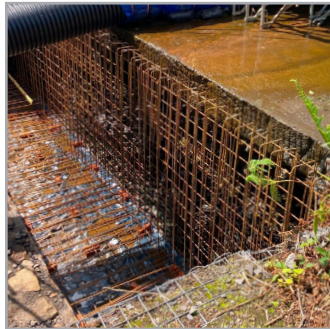
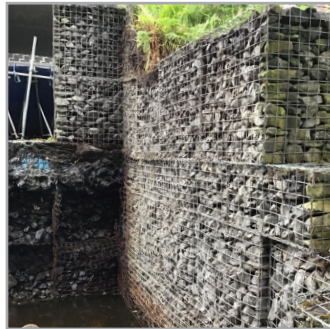
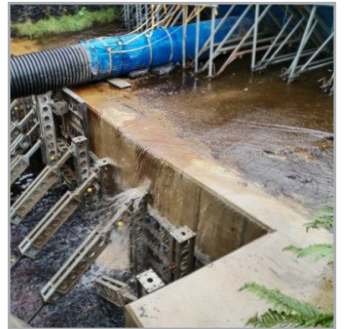
The team dismantled the degraded gabion baskets as well as some additional baskets to create room to cast the new support structure, while stockpiling the stone for reuse.

Stonbury replaced the perished gabion baskets at the end of the spillway with a more durable concrete wall to secure the assets long-term safety and functionality.

After installing a ramp and scaffolding access into the upper and lower sections of the spillway, Stonbury installed a Portadam system with a central relief pipe to release flows from the spillway onto the other side of the works. Coir silt traps were placed on the lower side to catch debris and prevent it entering the watercourse.

The area in front of the spillway was excavated and levelled with new stone before a concrete base and kicker was laid. Steel reinforcements were affixed on the concrete face and shuttering and formwork was installed in which to cast the new concrete wall and wingwalls.

Once the concrete was cured and the shuttering and formwork had been removed, the team instated new gabion baskets flush with the exiting baskets and the newly cast wall and filled them with the saved stone.

The new concrete wall has restored the structural integrity and safety of the asset and has provided improved ongoing erosion protection to the spillway.
