Stonbury was enlisted to install emergency erosion control measures to a riverbank in Northwest England after a section had collapsed.

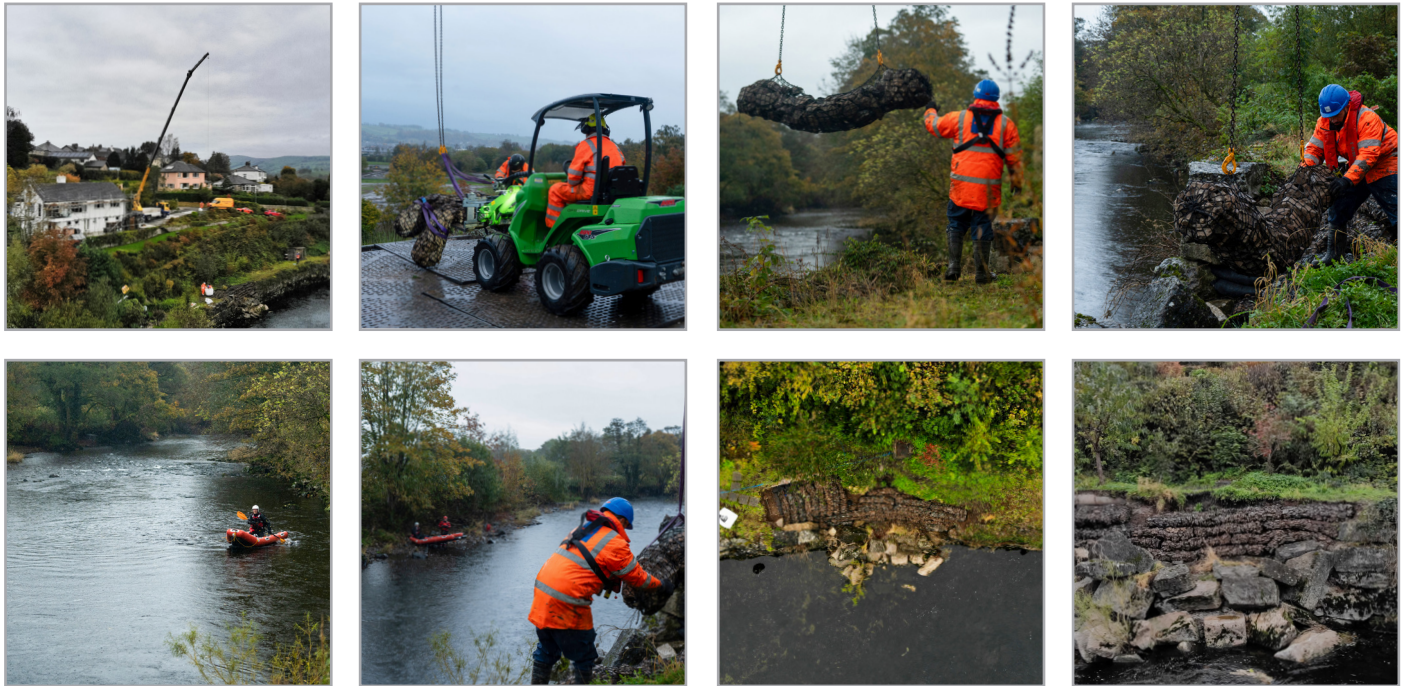
A riverbank wall on the River Kent had failed. The point of collapse was situated on a river bend and unfortunately coincided with an existing sewer main located in the garden of a local resident. The rising and falling of the water level during rainfall had eroded the exposed riverbank and undermined the sewer main. An temporary solution of Rock Roll – a robust and manoeuvrable stone system – was chosen to swiftly stabilise the riverbank and protect the existing sewer.

Once these measures were successfully in place, crane mobilisation and material deliveries began. 120 tonnes of non-calcareous rock material was used in the makeup of the Rock Roll basket system. Together with gravel pipe bedding, this was manoeuvred into position section by section, building the wall shape until all sections were complete.

Flex MSE soil bags were applied as a top section material to encourage regeneration of vegetation and finally covered with choir matting. The choir matting was utilised to secure and protect the underlying materials as well as to collect silt and seeds to assist the regeneration of the bank.
