//MAINTENANCE //REFURBISHMENT //NEW BUILD

PROJECT APPLICATION OF BONDED MEMBRANE TO CYLINDRICAL COLUMNS

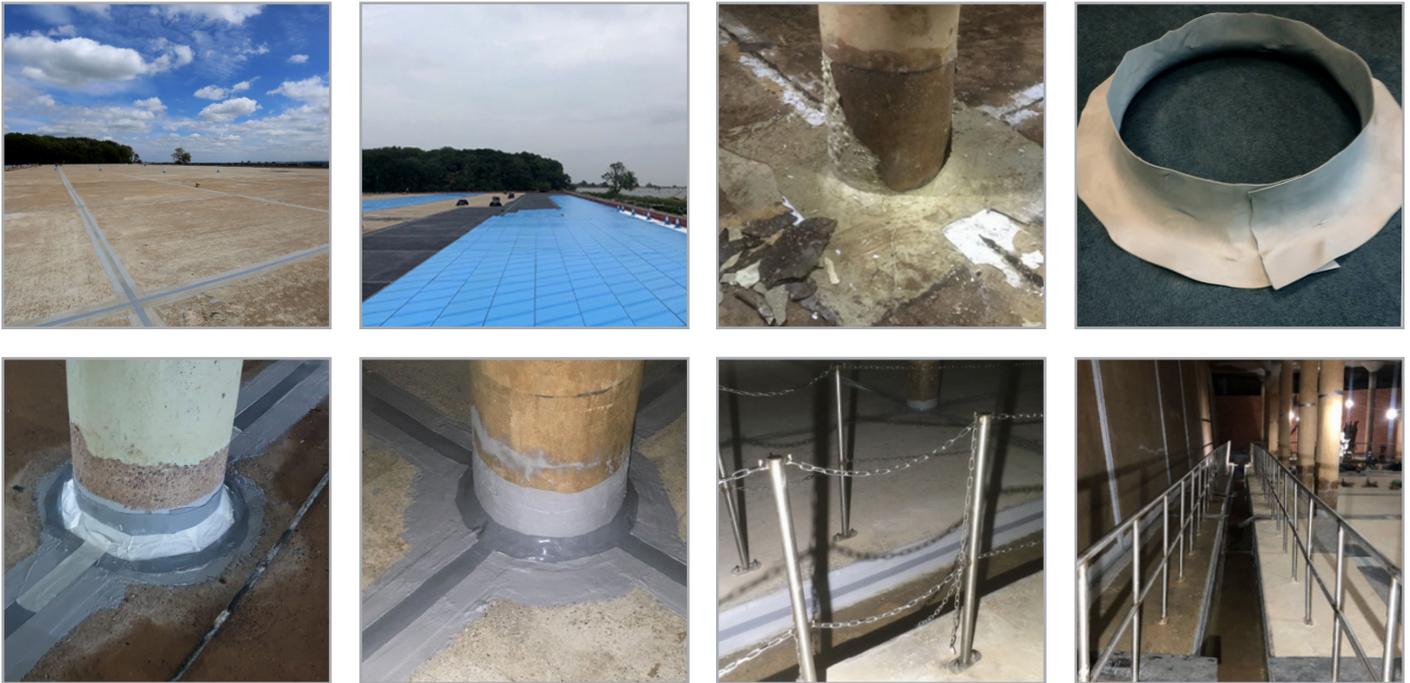
The team were required to carry out the application of bonded membrane to over three hundred cylindrical columns. This was an extremely time-consuming task which could have been costly for the client. In addition, due to the number of welds required, the risk in terms of potential points of failure was much higher.

Following discussions, the delivery team suggested a watertight, pre-formed ring to save time and money whilst maintaining the required quality standards. Stonbury developed several prototypes in-house, which were specifically designed to suit the reservoir's needs whilst maintaining the original thickness and strength of the existing overbanding strip.

The prototypes were trialled inside the tank and proved to be extremely successful, making the job much quicker, and reducing the time spent inside a confined space. The team also found the quality to be much better than the traditional method, in making the columns watertight and providing a neat and tidy finish.
