Stonbury's concrete repair work has prolonged the life of a primary settlement tank on a sewage treatment works in the Midlands.

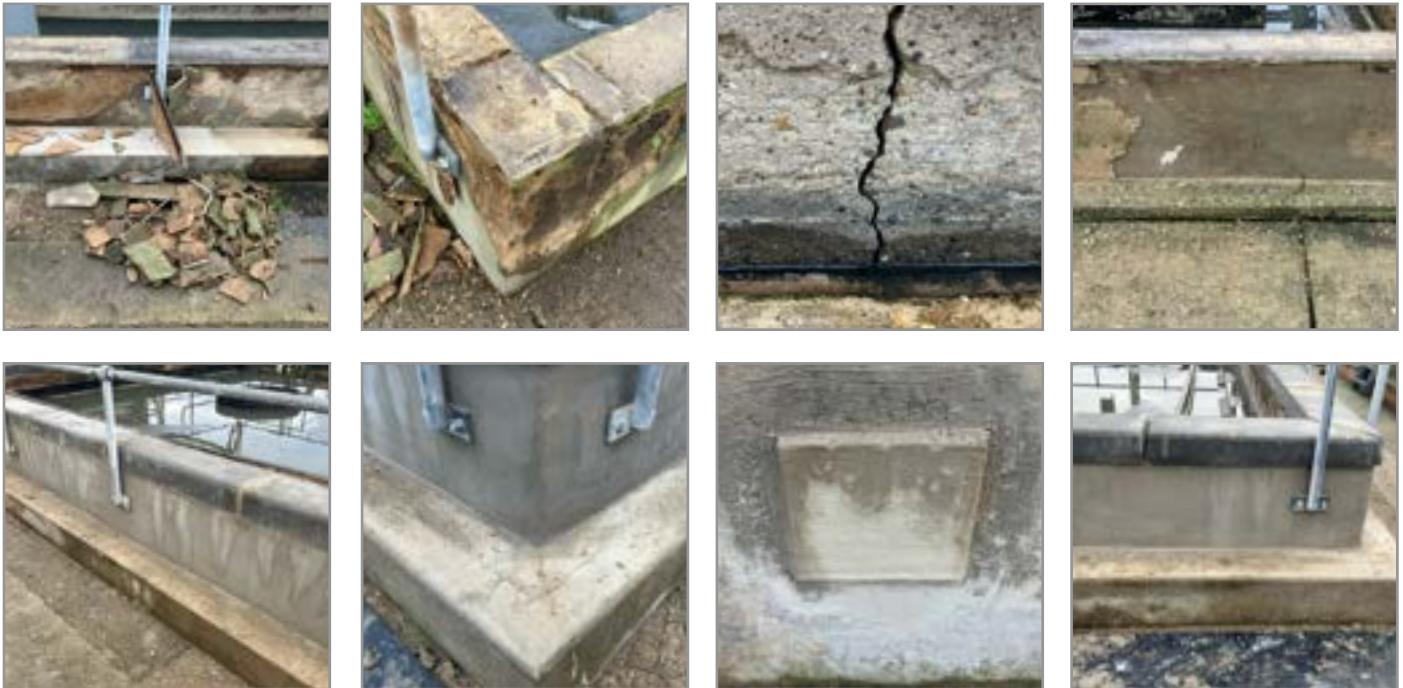
The tank had several cracks visible on the inside and outside walls which was causing leakage. In addition, the top coping stones had degraded and loosened.

After mobilising to site, Stonbury cleaned the internal wall with high-pressure water jetting (HPWJ), to remove debris and any loose substrate.

The team then removed all the coping stones and the exterior render. Once the render had been removed, there were obvious signs of water leakage from the cracks.

All the cracks on the internal face were saw-cut to a depth of 10 millimetres using a grinder equipped with a diamond blade. A specialised concrete repair product was applied to each repair site.

Once the internal crack repairs had set in accordance to the manufacturer's Instructions for Use (IfUs), a Masterseal 586 waterproof coating was applied to the entire internal wall to help protect the tank from further degradation.

The crack repair method was repeated on the tank's external faces before re-rendering the external walls using Natcem 35 render. Pull tests were carried out to ensure the product had set correctly and provide assurance of a high-quality, long-lasting finish.

Finally, the degraded perimeter coping stones were replaced with new and bedded into position.
