Early contractor involvement resulted in a timely and cost-effective solution for a seized sluice gate that was causing uncontrolled flows.

The sluice, located in Bedfordshire, consists of two steel gates operated vertically by overhead apparatus driven by actuators. It helps to control local water levels on the Great Ouse River.

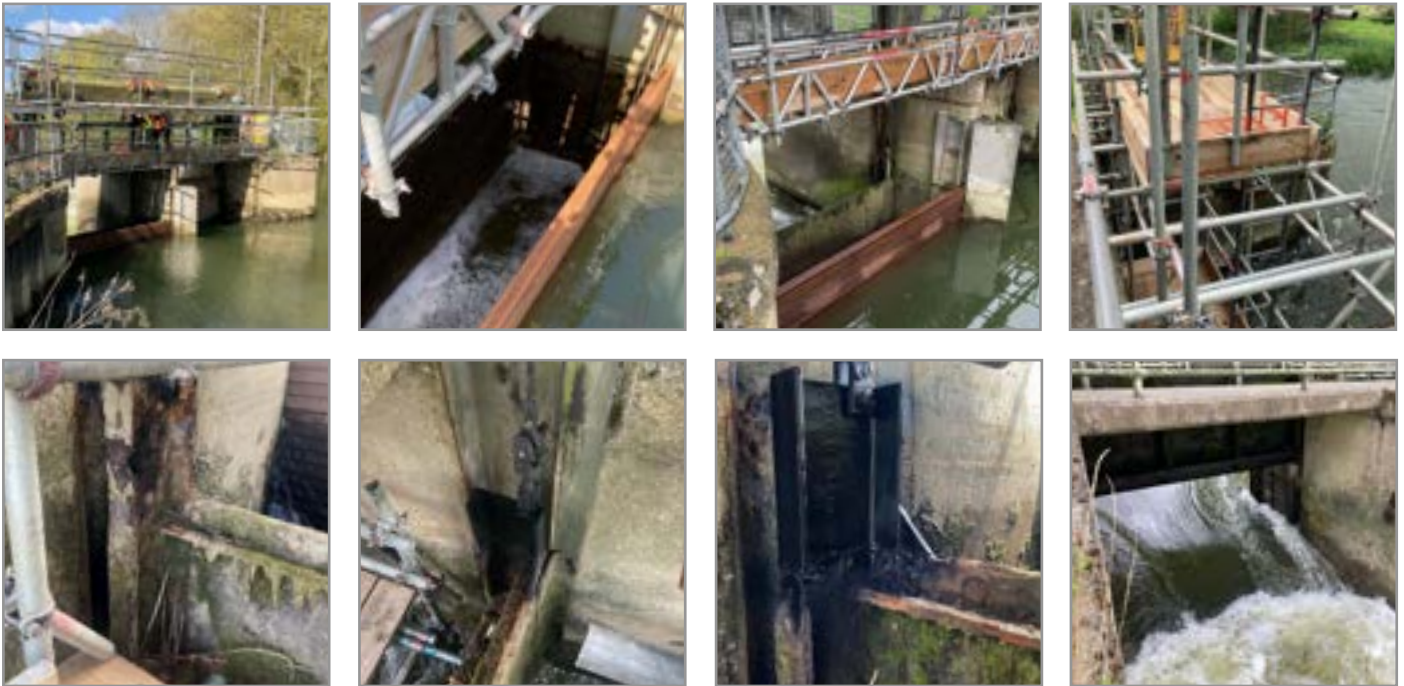
One of the gates had become stuck at a high level resulting in excessive water flow, lowering water levels and water pressure and putting upstream embankments at risk of collapsing. This problem was also affecting the old millstream leading to the culverts running underneath the old mill building. While the water levels under the mill structure were so low, Stonbury was employed to inspect the condition of the culverts and facilitate investigation of the damaged sluice.

Secondary temporary access was erected down into the sluice channel to provide access to the sluice gate trod wheels. It became apparent these had failed due to corrosion over time, resulting in the gate actuators tripping out during automatic movements. The team were able to immediately free the wheels by cleaning off corrosion, applying environmentally safe lubricants and refabricating the distorted metal framework.

The inspection revealed that the second gate had also suffered excessive corrosion to the side where one of the operating steel ropes was anchored. Holding the gate at a suitable height using lifting tackle and applying props underneath as a secondary safety measure, Stonbury removed the corroded section and welded a newly fabricated section of steel framework into place.

After scaffolding had been erected by a specialist sub-contractor, Stonbury deployed stop logs into the masonry channels of the sluice, allowing a closer inspection of the sluice gate structure to be carried out. Stonbury's in-house specialist confined space entry team conducted a visual inspection of the culvert structure and completed repairs to damaged brickwork on front-facing abutments.
