Stonbury was contracted to refurbish and replace the roof on an above-ground, modular bolted glass-fused-to-steel (GFS) tank.

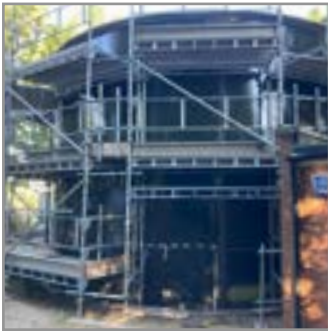
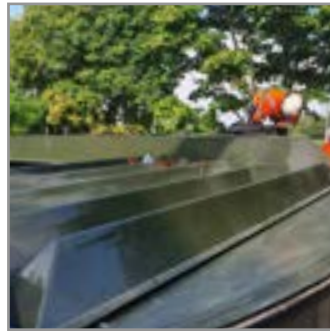
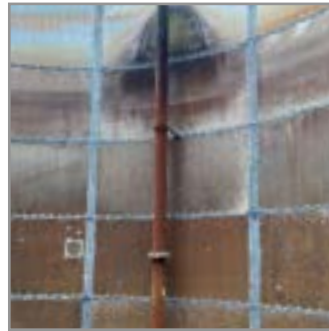
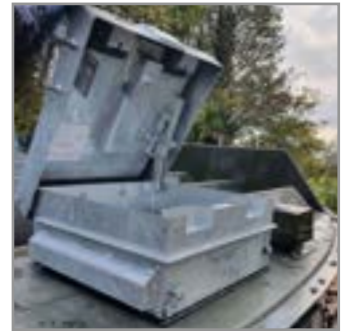
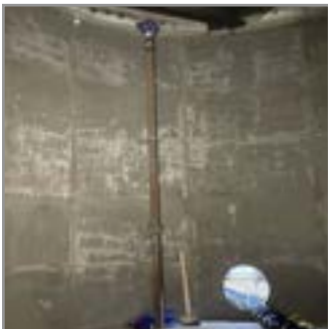
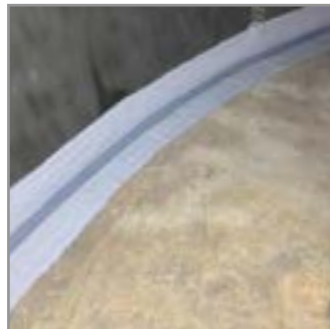
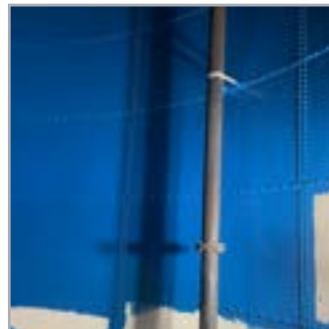
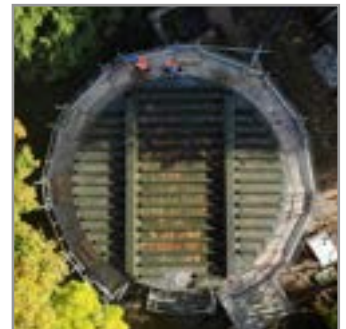
A flood test carried out by the client indicated water ingress through the GRP roof of the tank. Further investigation highlighted deterioration of the joints between the roof panels as the cause for the water ingress. As the GRP roof was beyond its original maximum design life, a complete replacement was required. During the programme Stonbury was further contracted to deliver a refurbishment to the entire tank.

An inspection of the internal walls of the tank revealed wide-spread surface corrosion under calcite deposits. Therefore, the client asked the team to remove all the calcite to investigate the full level of corrosion, which the team completed using low pressure water jetting. Once the corroded areas were revealed and reported to the client, Stonbury was asked complete a full refurbishment of the steel wall panels, including overbanding of all joints.

The team erected scaffolding around the structure and cut an access manway into the side of the tank to allow access for scaffolding to support the structure whilst fitting the new roof. The existing roof was replaced with a newly designed GRP roof, expected to last for a minimum of 20 years. A new steel SR4 rated access hatch was then fitted.

The team prepared the substrate to receive overbanding system and Regulation 31-approved polyurethane coating by grit blasting and crosshatching the steel and concrete surfaces in accordance with ISO 8501-1. A heating system was then installed to ensure the materials were applied and cured as per the Instructions for Use (IFU). Surface temperatures, air temperature, dew point and relative humidity were continuously monitored. Once cured, a spark test was completed to confirm the coating was free from defects.
