PROJECT BANK STABILISATION

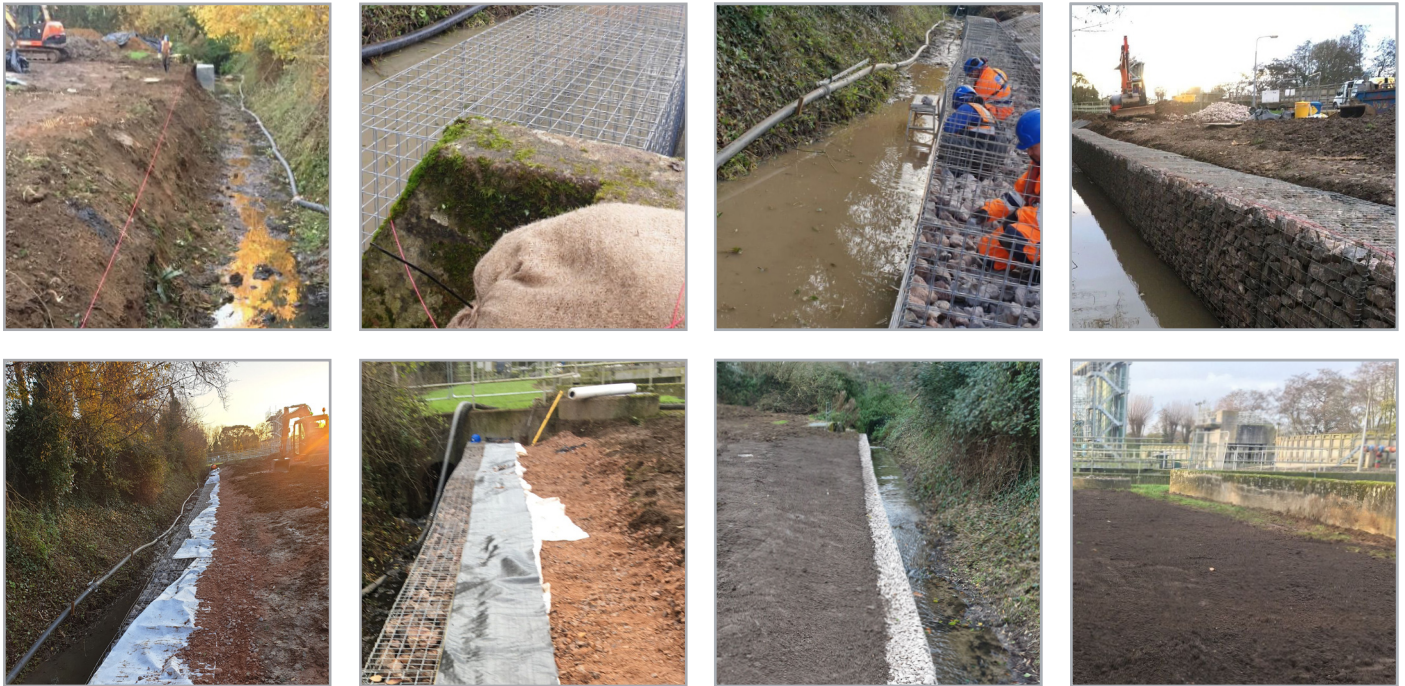
Gabion baskets were fitted along the left bank, with two layers of reinforcement wire between each gabion to prevent the baskets from bulging.

The baskets were then filled with stone, and once complete, works began on a second tier. All the baskets forming the top tier were tied to the bottom row for stability.

Once complete, a layer of geotextile was used to line behind and on top of the baskets for additional stabilisation and filtration. The team then backfilled the area with soil and began re-shaping the bank back to its original state.
