## PROJECT WTW SURGE VESSEL REPLACEMENT

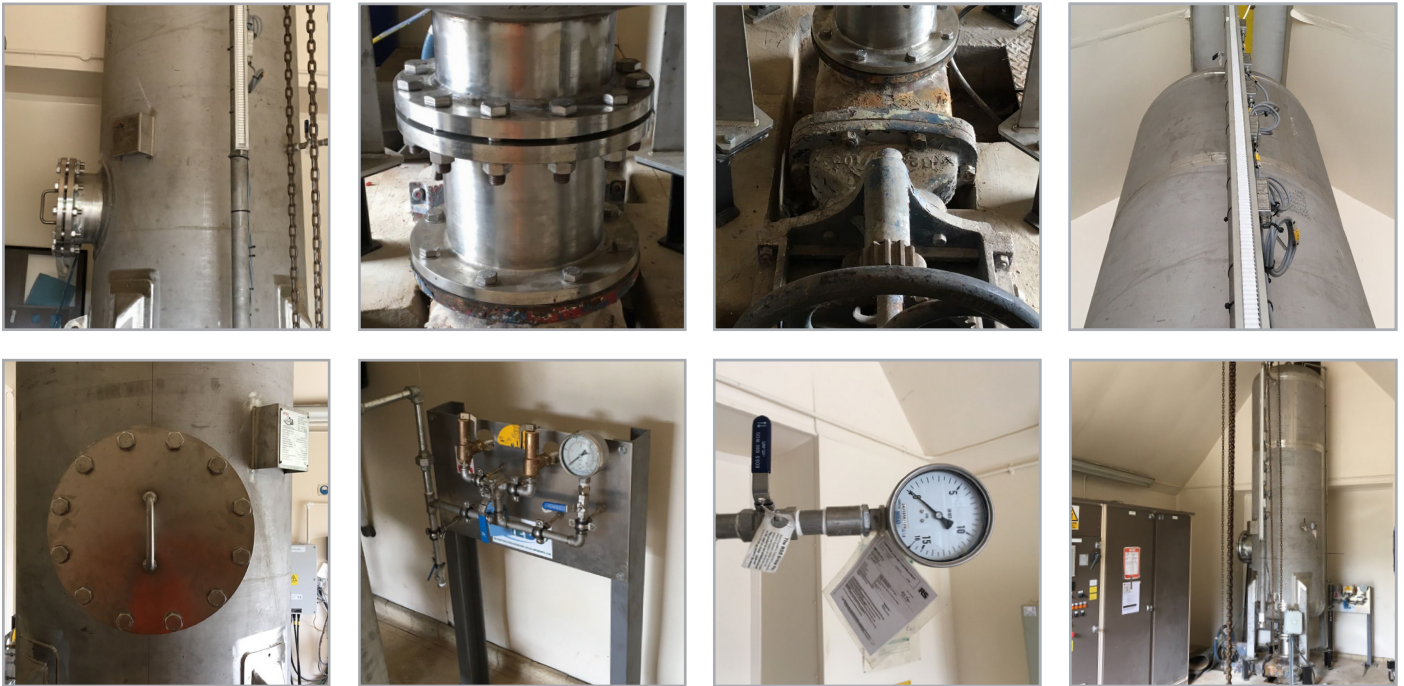
Stonbury were contracted to repair a surge vessel situated on a water treatment works site. The vessel had failed the relevant pressure vessel insurance requirements and after inspection of the asset, evidence of coating delamination and corrosion was also found.

Due to the relatively small diameter of the surge vessel, a new and compliant manway could not be installed, as this would not allow for the required grit blast and coatings. Resizing the vessel was also not an option as the building had insufficient space to house a bigger system.

It was decided the most practical solution was to design, fabricate and install a replacement vessel, using corrosion-resistant stainless steel. The new design would not require the application of any internal coatings and removed the necessity for a 600mm diameter manway.

Once the design work was complete, the vessel was constructed off-site and a non-destructive test was performed to ensure the vessel had been designed and fabricated to meet all relevant specifications. A 300mm inspection hatch, fitted with a blind flange and handles was also installed for future testing.

The new surge vessel was moved into position using the buildings original tracked winch, which was tested by the client prior to works commencing on site. Once in position, the original gauges, airlines and valves were connected, and the asset was cleaned ready for inspection.
