Stonbury completed masonry repairs to three bio-filter beds in the South of England. The works took place in sequence to allow the bio-filters to remain in service for the twenty-week construction program duration.

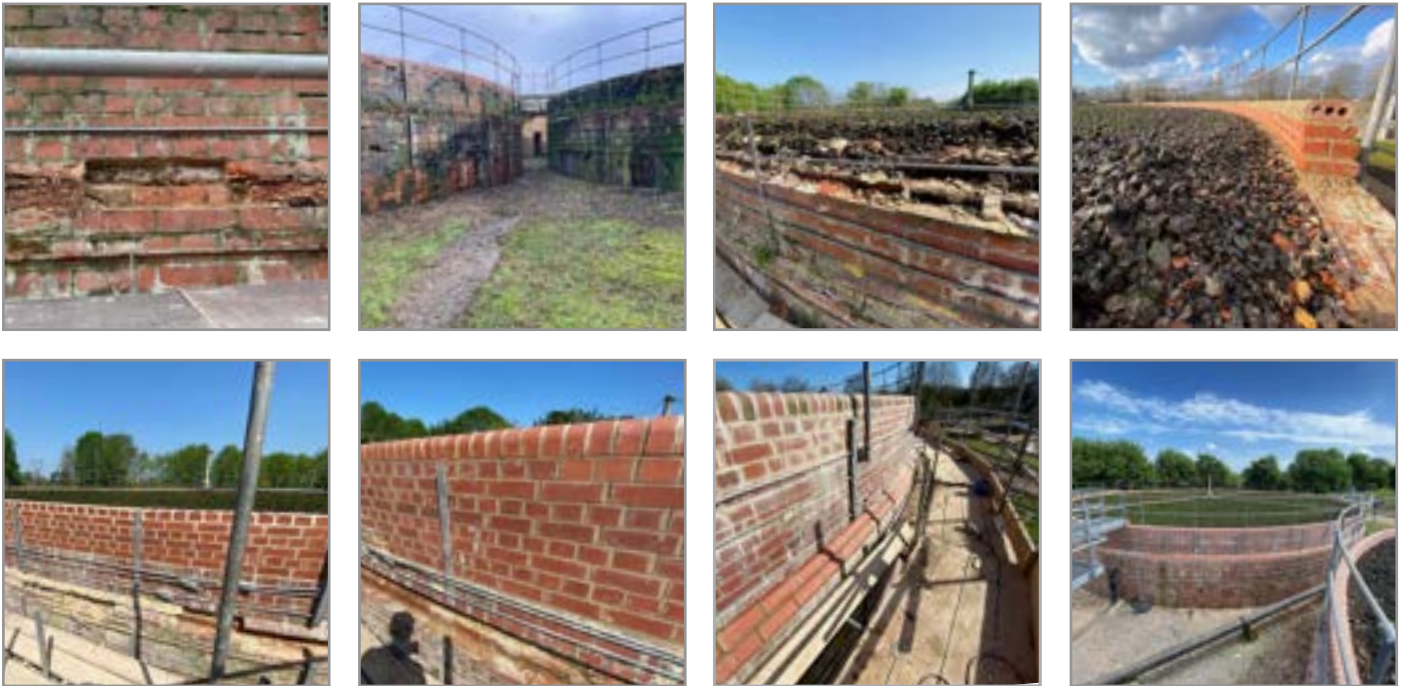
The repairs were required to extend the life of the filter tanks which had become damaged over time by tree roots, vegetation and the elements. The existing brickwork had begun to crumble, and at the lower levels of the filter beds, the mortar joints had started to leak.

Initial works included a pressure wash clean and the removal of roots and vegetation, which had penetrated the brickwork in some areas. An inspection was then carried out to allow the team to identify hidden cracks and additional leaks within the walls.

The coping stones were then removed from each twelve meter section, and the brickwork was demolished by hand to the required depth. The walls were re-built – re-using existing bricks where possible – and the coping stones were laid around the top of the wall. The chamfer was also removed in specific locations and re-laid.

Once all the brickwork was reinstated, repointing, stitching and overbanding were carried out to ensure a watertight finish.
