PROJECT SLUDGE TANK REFURBISHMENT

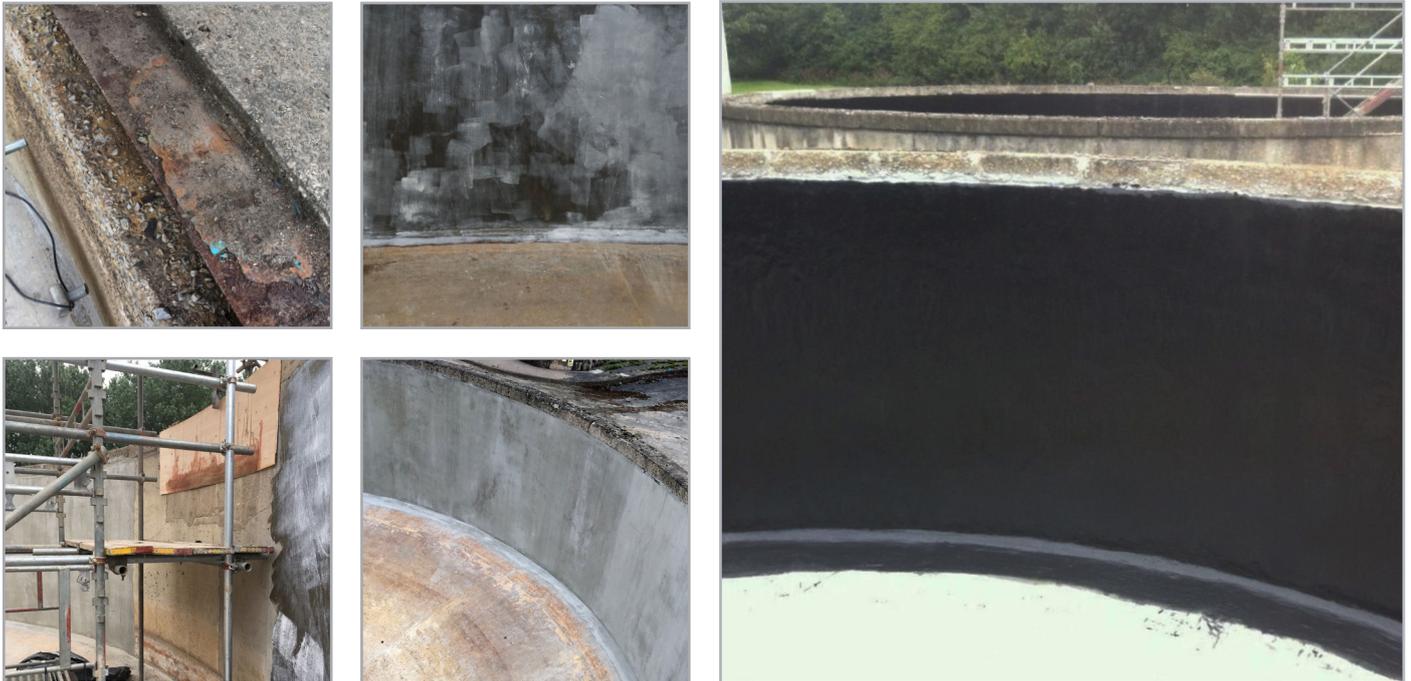
Stonbury were contracted by a framework client to refurbish two sludge holding tanks at a STW constructed in the early 1970's. The works formed part of a larger upgrade to the WWTW and this element of the project required specialists in the application of chemical protective lining systems.

Works included HPWJ (high pressure water jetting) to the walls, localised treatment to existing cracks using a suitable cementitious repair mortar and the application of waterproof and chemical resistant coatings.
