Stonbury was contracted to carry out repair works to a flume weir which had failed due to a leak around the wing wall. The leak had eroded the bank to such an extent that a large void had formed.

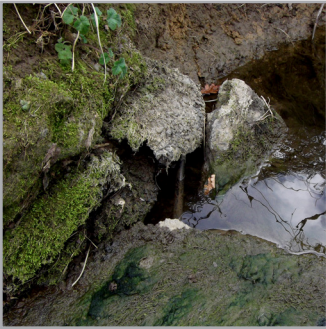
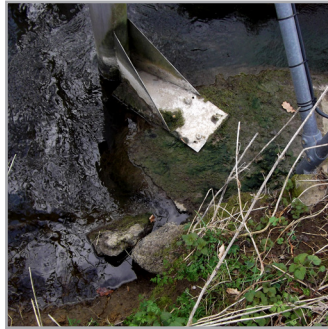
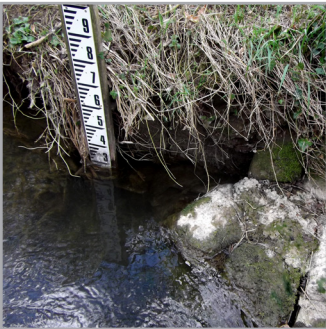
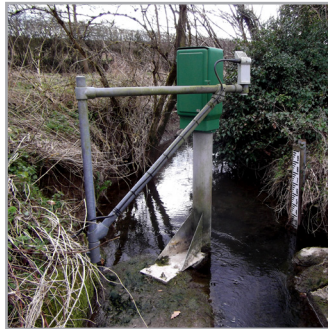
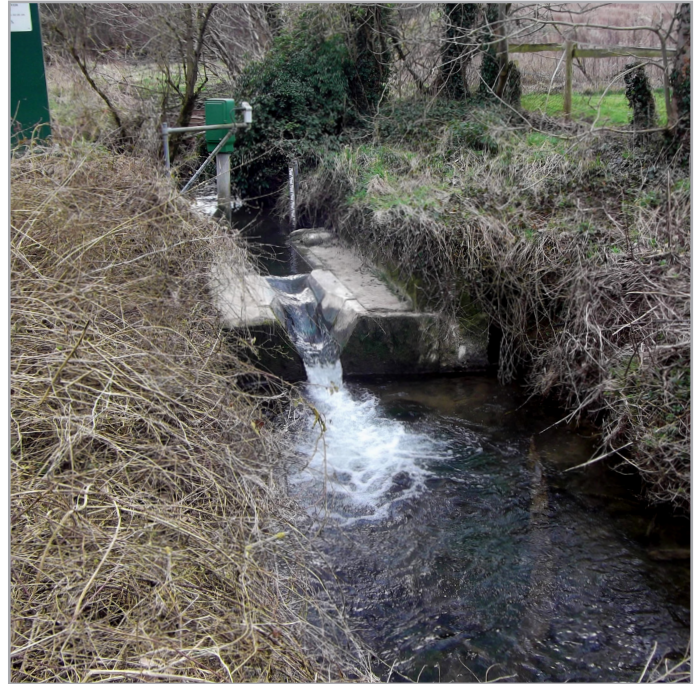
A temporary cofferdam was installed to divert the water flow around the working area, and an excavator was used to dig down behind the wing wall to a depth below the existing leak. The landward side of the excavation was then battered down to a slope of 45 degrees.

The back of the wingwall was then cleaned, inspected and repaired. Bentonite powder was used to dress the back of the wingwall and sides of the excavation, and imported clay was used to rebuild the bank and backfill the void.

Upstream, a section of the bank was faced with concrete-filled sandbags and reinforced with steel pins, to provide erosion control.

The gauge board was also replaced and fixed to a galvanised mild steel post driven into the stream bed. The new gauge board was levelled into a stored datum to avoid the need for recalibration of the monitoring equipment.

To complete the works, the cofferdam was removed, the bank was reinstated, and the area was seeded with a suitable grass mix.
