PROJECT WAVE WALL INVESTIGATION

Stonbury was contracted to complete investigation works into the condition of an existing wave wall structure on an impounding reservoir. This was part of a long-term strategy due to the early signs of degradation from long term exposure and erosion from wave action.

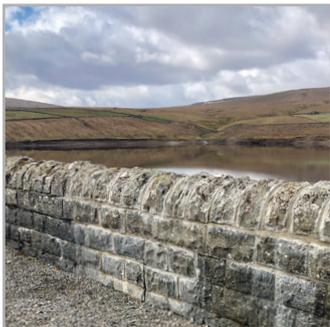
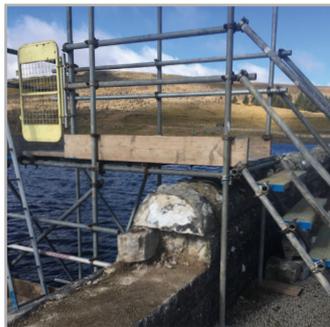
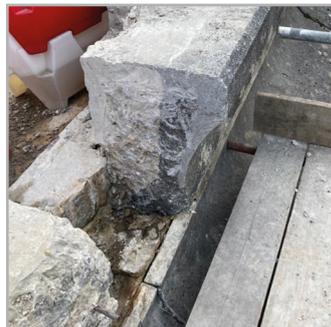
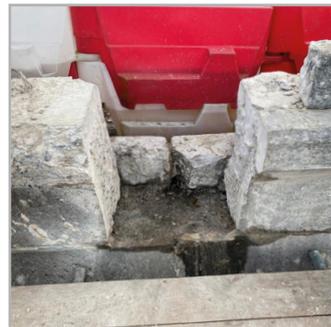
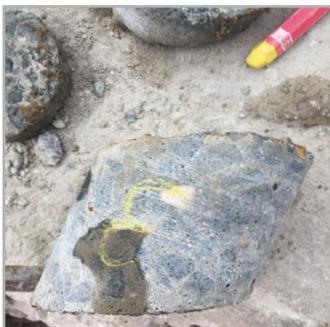
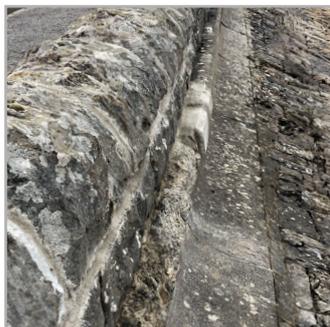
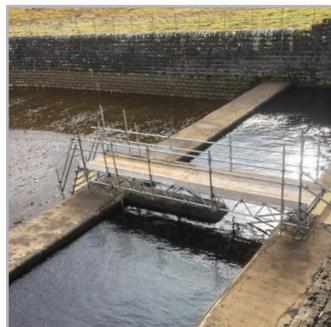
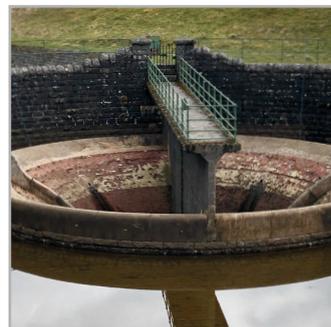
The wave wall consists of pre-cast panels to the water side, with a dry-stone wall set into the concrete on the side facing the road; although historic drawings were unclear on how these interacted, so this formed part of the investigation.

After the two areas were segregated from the public and scaffolding was erected to provide safe access to the work area and means of rescue, the existing stone wall was dismantled. To ensure that it was possible to rebuild the wall to its original integrity, the stone blocks were numbered and carefully reapplied in the same order during the rebuilding.

Once exposed, the concrete was cut and removed with 300mm clearance to either side of two identified construction joints, as instructed by external engineers who were overseeing the investigation works. Stonbury completed several non-intrusive surveys including ferro scanning, crack assessments and condition surveys.

Multiple cores of varying depths were drilled from the removed sections in the locations specified in a report provided by the client and were sent for detailed analytical sample analysis. Following completion of the investigations, the wall sections were reinstated to match the existing build detail. The wall is now repaired, and we are awaiting results from the extensive concrete analysis.
