As part of an ongoing inspection and maintenance programme, Stonbury was contracted to carry out refurbishment works to one of the client's surge vessels. This included fitting a new manway and recoating the internal surfaces.

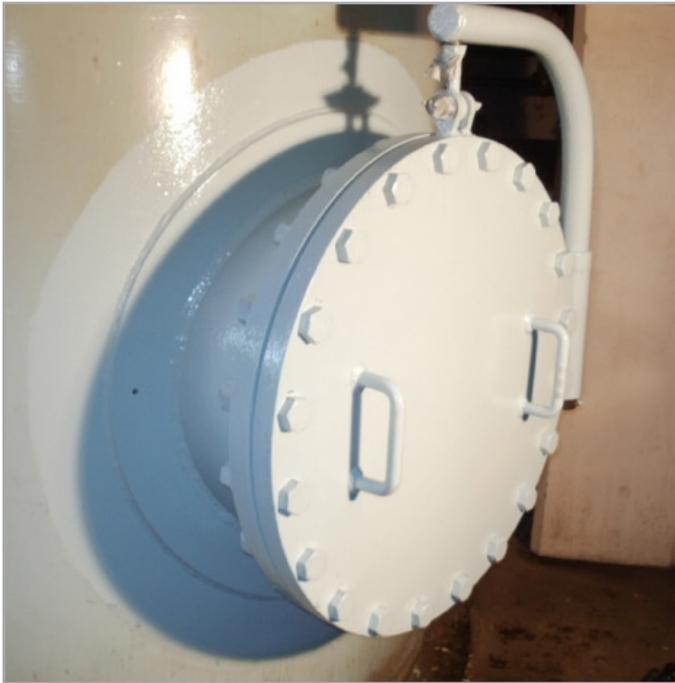
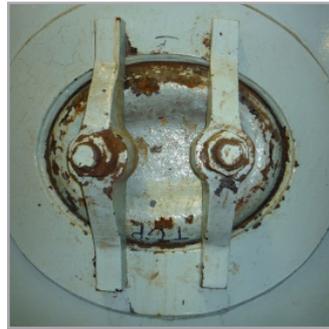
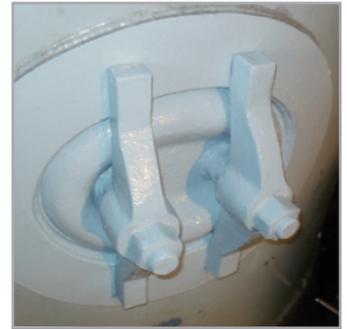
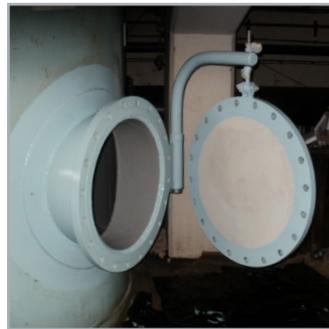
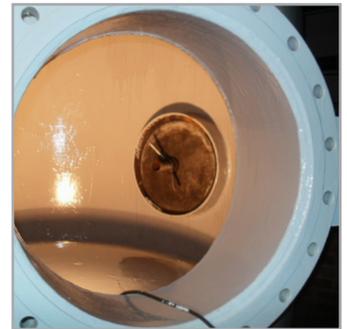
A full internal access scaffold was erected to facilitate the internal refurbishment works. After this was installed, the existing coating (bitumen) was removed by grit blasting, which was completed to carefully direct all extracted dust and debris from the surge vessel into an outside skip and avoid it entering the valve house.

The vessel was then drained and allowed to fully dry. The scaffolding was re-erected for the final coating works. The internal surfaces of the vessel were coated with a solvent-free urethane to a minimum dry film thickness (D.F.T) of 1000 microns (1mm) to give a maintenance-free life of 20 years. Finally, scaffolding was dismantled, and all external connections were re-fitted.
