MAINTENANCE REFURBISHMENT NEW BUILD

PROJECT ABANDONED RESERVIOR CONVERSION

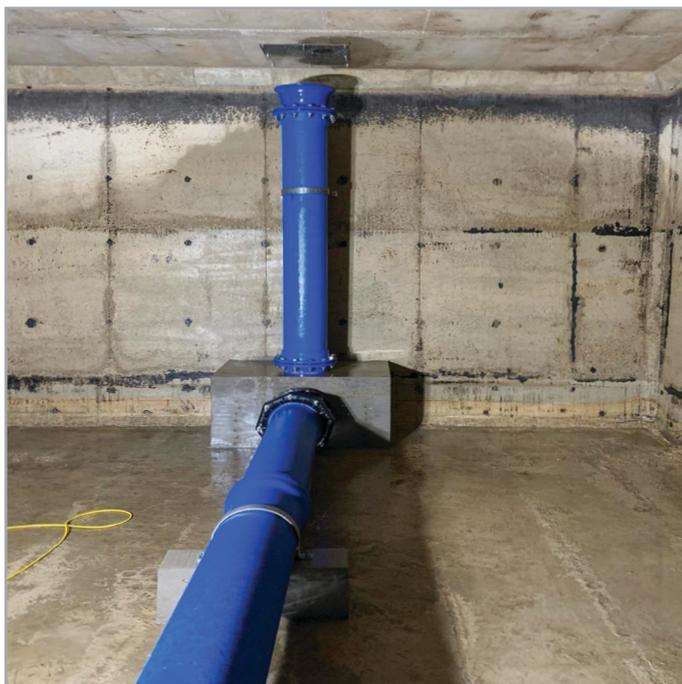
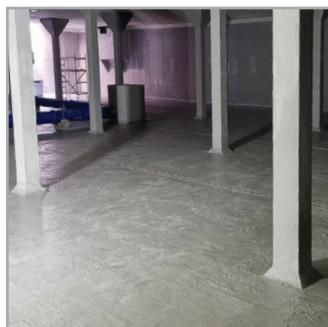
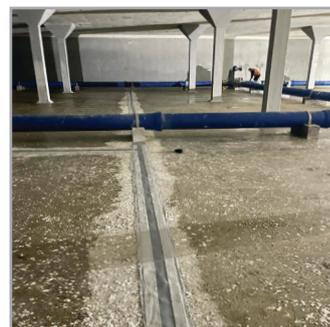
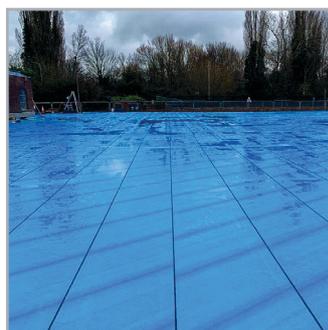
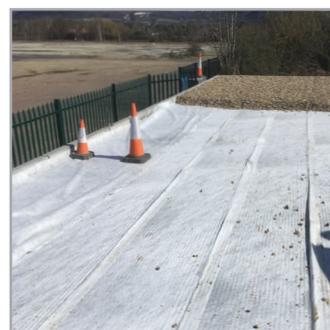
Stonbury was contracted to repurpose a redundant 1950s-built raw water reservoir into a potable water service reservoir after increased demand called for urgent new capacity. Significant works were required in a short space of time to upgrade the roof, pipework, and internal surfaces to convert the reservoir for clean water use.

After works had commenced to clean the tank, seal 60 air vents, demolish and replace upstands, waterproof the roof, and replace internal pipework, a number of challenges occurred. An inspection from the Drinking Water Inspectorate (DWI) stipulated that all internal surfaces were to be coated, including the roof soffit, columns, walls, and floor in the main and overflow chambers.

To seal the tank, the decision was made to overband the entire floor, wall joint perimeter and all floor joints. Throughout the night, this area was taken back to concrete and cross hatched and pull-off tested. Approximately 600 metres of overbanding was applied over two to three days.

To avoid delaying coating until Masterseal 586 was available, the roof soffit was double-coated using Masterseal 581 and Stonbury's expertise ensured another suitable drinking-water safe product, Flexicrete 851, was sought for the remaining internal surfaces consisting of the columns, walls, and floor.
