PROJECT BAFFLE WALL REPLACEMENT

Due to the presence of Chrysolite Asbestos inside a drinking water contact tank, Stonbury were contracted to remove a contaminated baffle wall and its supporting steel structure. The wall was to be replaced with a new thermoplastic baffle curtain.

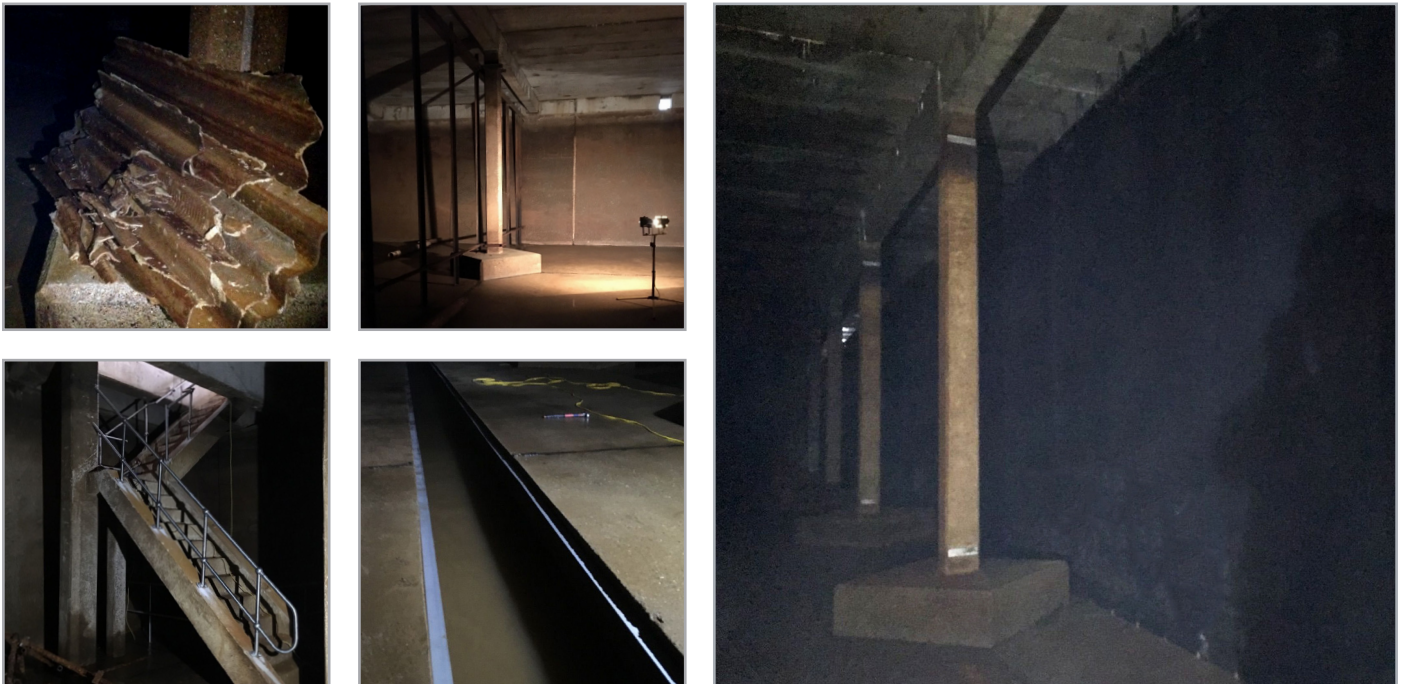
The existing baffle wall was made up of corrugated sheeting and fixed into place on a steel frame. The sheeting required removal by specialist contractors and once complete, the steel frame was dismantled and removed from the tank in sections.
