PROJECT BRIDGE & SPILLWAY REFURBISHMENT

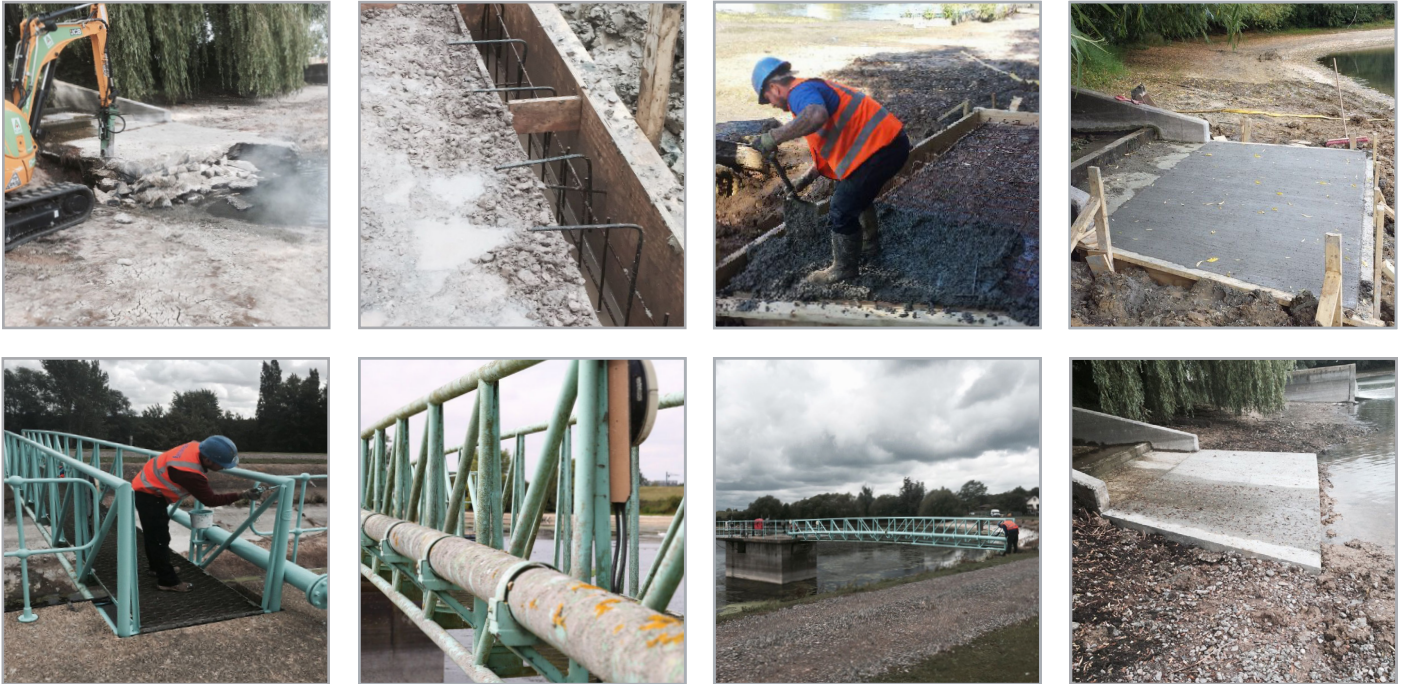
The bridge came up in a section 10 inspection, which was deemed to require attention. It was decided that a new protective paint system would be applied to the whole structure.

The bridge itself was to gain access to valves positioned within the impounding reservoir so spanned from the embankment and across 20 meters of water. This caused access challenges because the impounding reservoir could not be drained. So to gain access to the underside of the bridge, we installed floating pontoons onto the water which enabled us to work safely underneath the bridge.
