PROJECT STEEL TANK COATING APPLICATION & REMOVAL

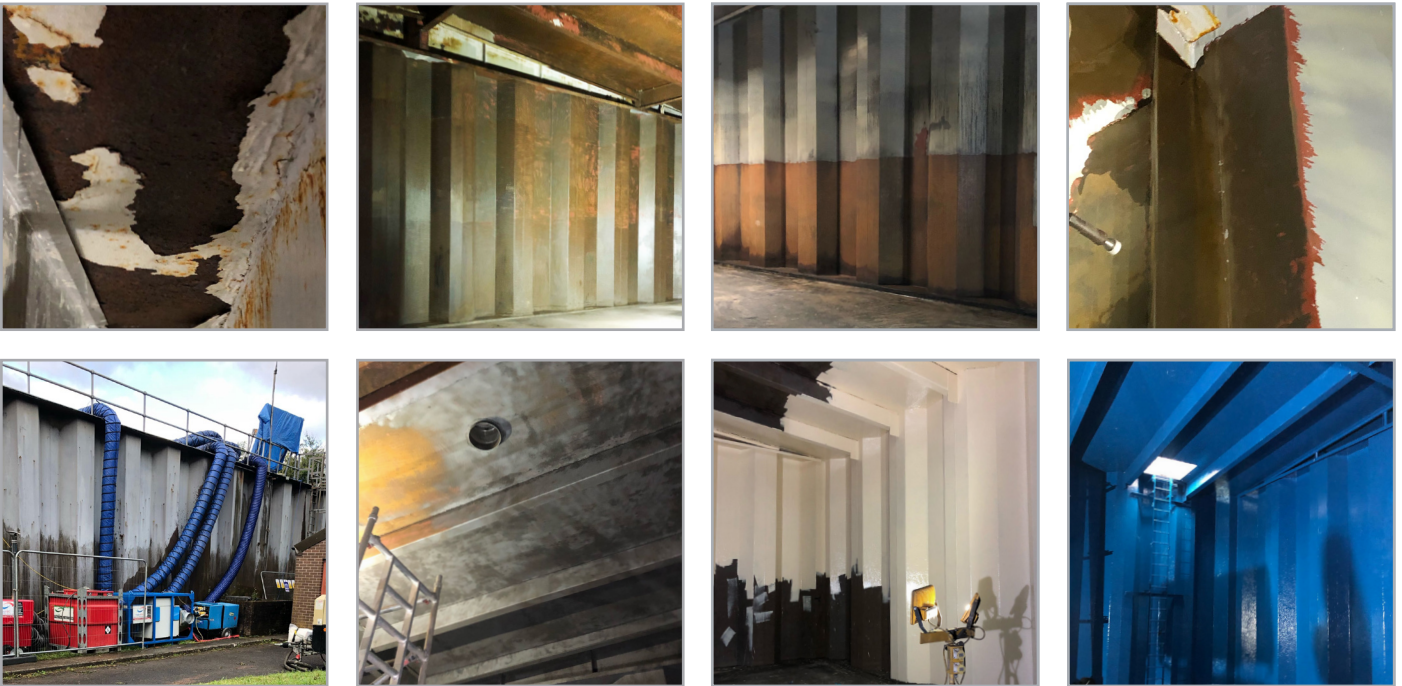
Following a statutory inspection by the client, Stonbury were contracted to complete refurbishment works inside a steel tank, which showed severe signs of rusting and peeling of the existing coatings to the walls and soffit.
