## MAINTENANCE REFURBISHMENT NEW BUILD

### PROJECT WAVE WALL INVESTIGATION

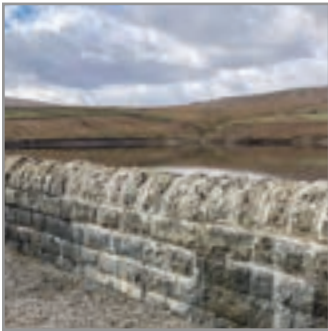
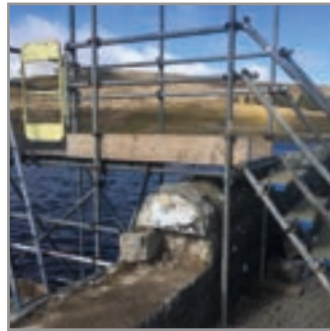
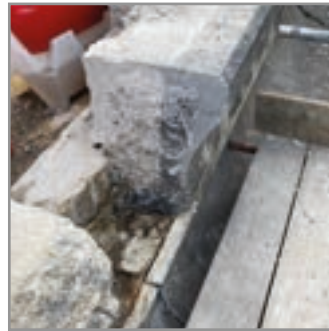
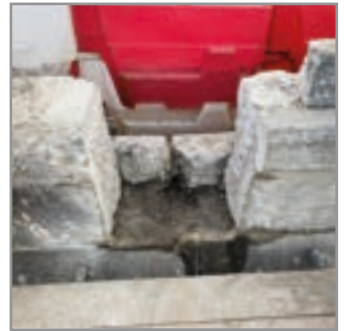
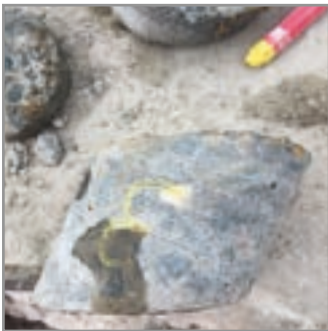
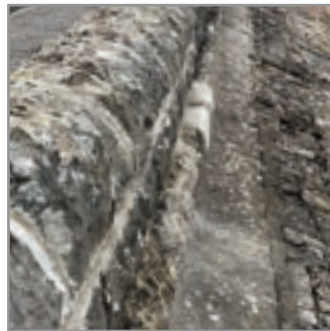
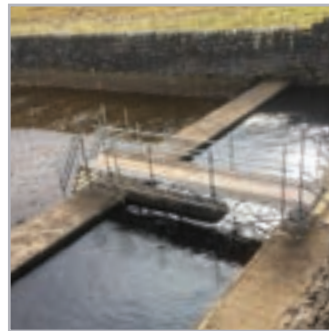
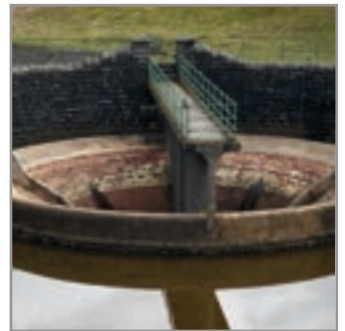
The wave wall consists of pre-cast panels to the water side, with a dry-stone wall set into the concrete on the side facing the road; although historic drawings were unclear on how these interacted, so this formed part of the investigation.

After the two areas were segregated from the public and scaffolding was erected to provide safe access to the work area and means of rescue, the existing stone wall was dismantled. To ensure that it was possible to rebuild the wall to its original integrity, the stone blocks were numbered and carefully reapplied in the same order during the rebuilding.

Once exposed, the concrete was cut and removed with 300mm clearance to either side of two identified construction joints, as instructed by external engineers who were overseeing the investigation works. Stonbury completed several non-intrusive surveys including ferro scanning, crack assessments and condition surveys.
