PROJECT LOOSE LINER INSTALLATION

A loose-lay liner solution has provided long-lasting ingress protection to a steel contact tank within a rapid timeframe.

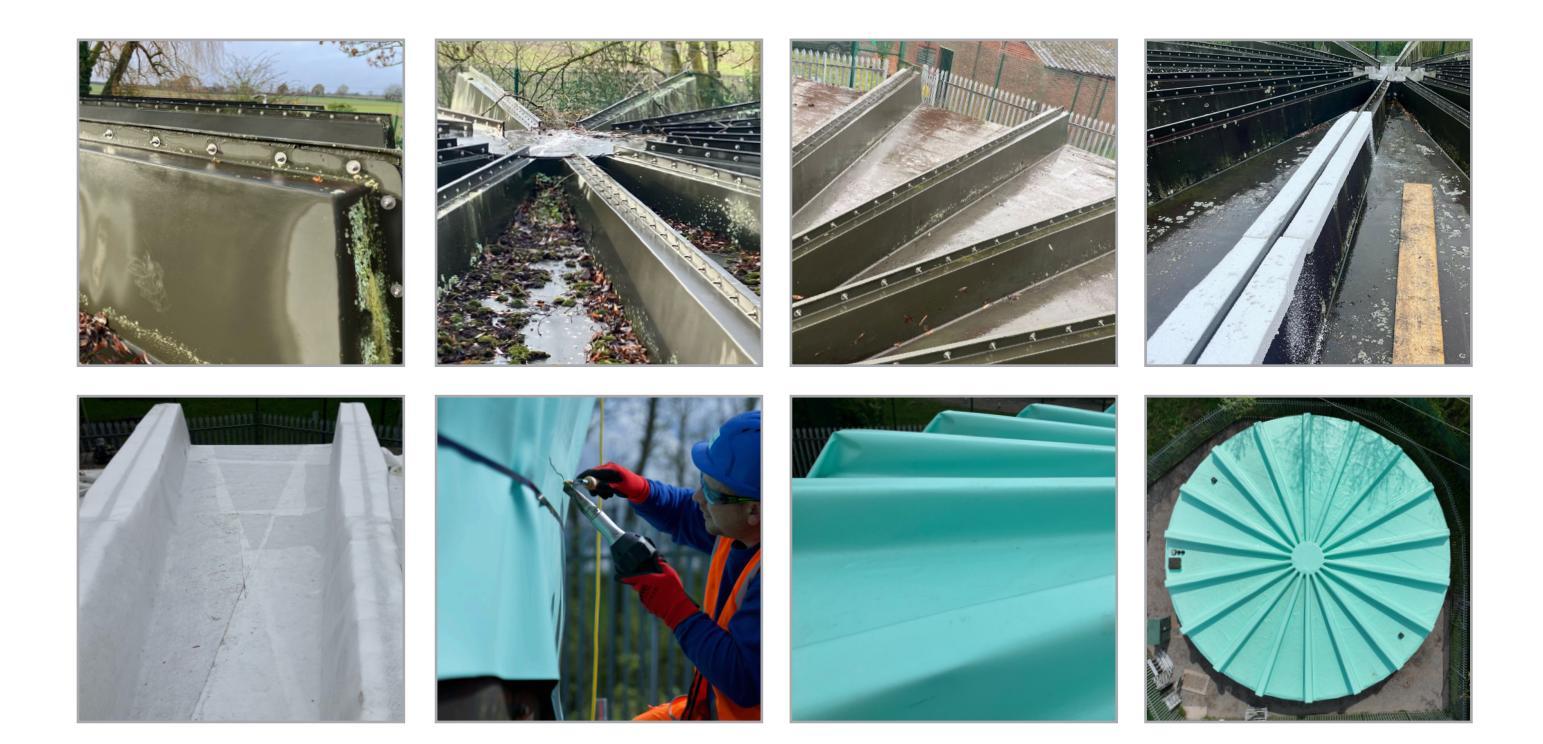
The tank, located in the Midlands, was experiencing ingress through the existing GRP roof after previous mastic repairs proved unsuccessful. Due to the extremely costly isolation of overhead powerlines above the tank, Stonbury and its client sought a suitable waterproofing solution deliverable in just four weeks.

A loose-lay Flagon solution was selected to guarantee the asset's rapid return to service without the risk of disruptions. To meet the deadline, Stonbury deployed additional labour to work during extended hours and weekends, which included its new team of highly skilled in-house liner specialists, specially trained to weld thermoplastic membranes.

During the planning phase structural engineers calculated the weight of the loose-lay liner system and the installation process to ensure the structure was safe to work on. Results informed a method of working which involved placing operatives systematically to avoid putting too much weight on each bay. Installing the liner on the panelled circular roof required meticulous attention to detail and involved carefully measuring, pre-cutting and intrusion welding hundreds of pieces of Flagon. Once the installation was complete, the roof underwent MIT-sensor testing, a flood test and a clean and chlorination.

Although the loose-lay liner is classified as a semi-permanent solution, it is highly robust and offers long-lasting resilience to thermal movement. The solution has significantly increased the asset's longevity and provided assurance that the tank will remain waterproof for many years to come.
