# MAINTENANCE REFURBISHMENT NEW BUILD

## PROJECT LOOSE MEMBRANE APPLICATION

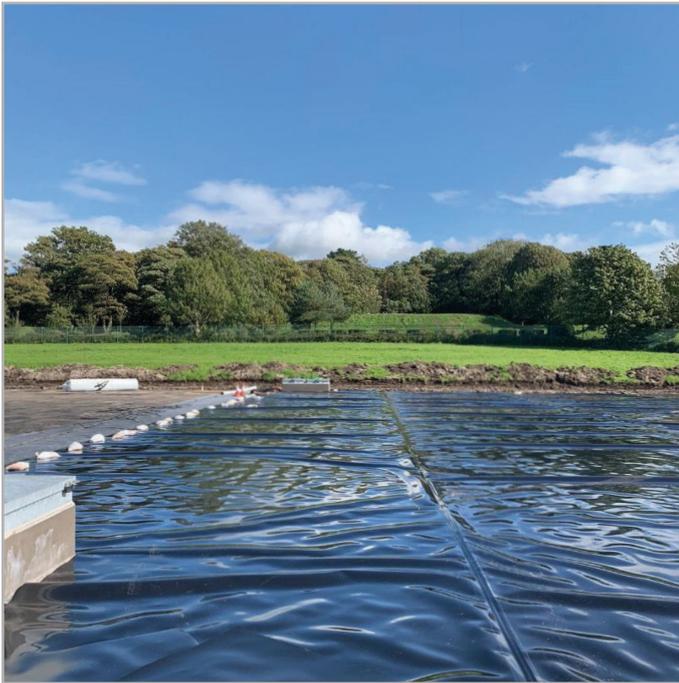
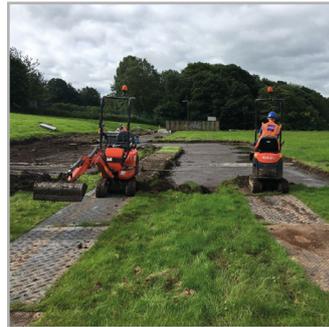
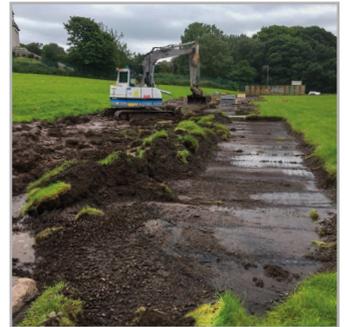
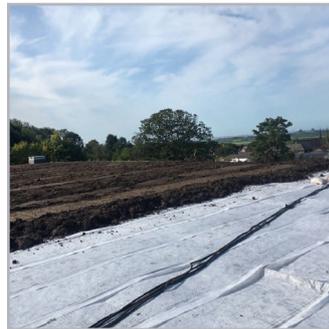
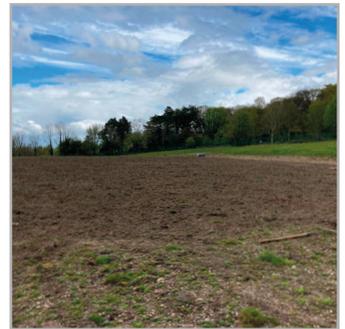
The original scope was to lay a new Premseal membrane. However, upon inspection it was apparent that around 85 per cent of the original bitumen membrane had perished. This would have needed to be completely removed in order to apply Premseal, adding many weeks to the schedule of works.

The team prepared the roof by removing the existing overburden, using a long reach excavator to remove soil from the edges of the tank to reduce time and ensure works stayed within programme. The team utilised five track barrows and two micro-diggers to minimise weight on the roof and hired a 7-tonne track dumper to minimise detrition on existing ground, saving money on the reinstatement.

The original bitumen coating was then left in place but jetted free of debris, and WLS (Waterline Solutions) were hired to lay the Flagon liner. Stonbury then applied the final membrane and

overburden reinstatement. Stonbury was also tasked with the removal and sealing of the existing vents. For reinstatement detailing, the team decided to re-utilise the stripped material, which is a preferred solution if soils are suitable, saving on cost and reducing carbon footprint.
