Stonbury was asked to provide a solution that would shield two above-ground steel tanks from the summer heat. The works were required as the temperature during the summer months was promoting the growth of bacteria inside the water tanks.

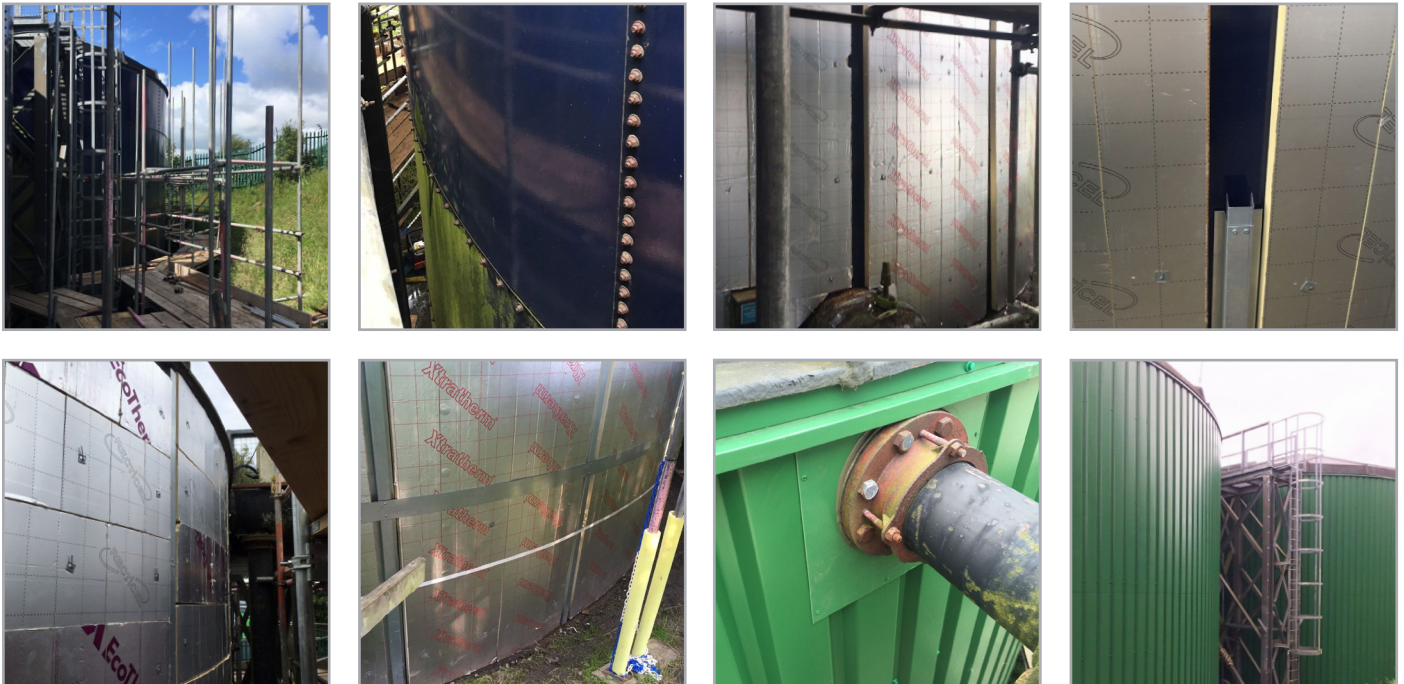
Once the preparation works were complete, the team installed low emissivity foil faced insulation board around the external walls of both steel tanks.

The boards were then secured into place with the use of upright galvanised steel supports which were strapped to the tank to remove any welding requirements.

Coated steel sheets were installed over the top of the insulation boards and securely fastened to the steel supports. Profiled steel flashings were then used to finish the cladding panels, preventing water ingress and protecting the insulation.
