## MAINTENANCE REFURBISHMENT NEW BUILD

### PROJECT RAILWAY CULVERT REPAIRS

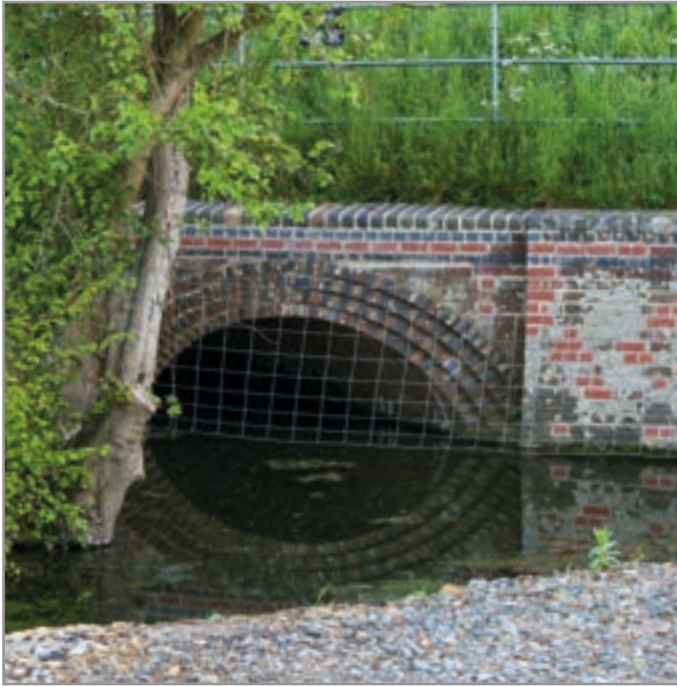
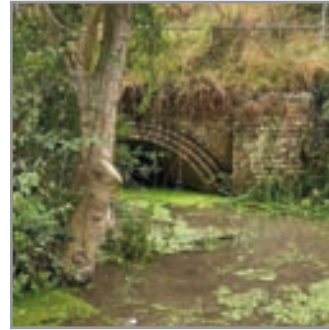
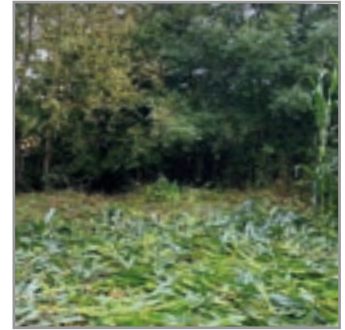
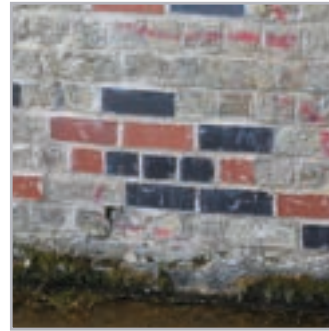
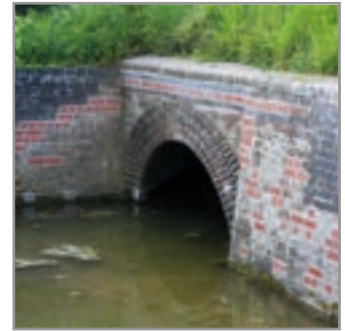
Once the structure was accessible, the team jet-washed the brickwork clean so that a thorough inspection could take place. During this inspection they identified several hollow bricks and crack lines not previously recorded on the initial survey.

All hollow bricks were removed and replaced, and crack lines were grinded and repaired with crack stitching. About a 20 metres squared area of crack stitching was completed and around 500 bricks were replaced.
