Stonbury was pleased to refurbish two granular activated carbon (GAC) tanks on a water treatment site in the north of England.

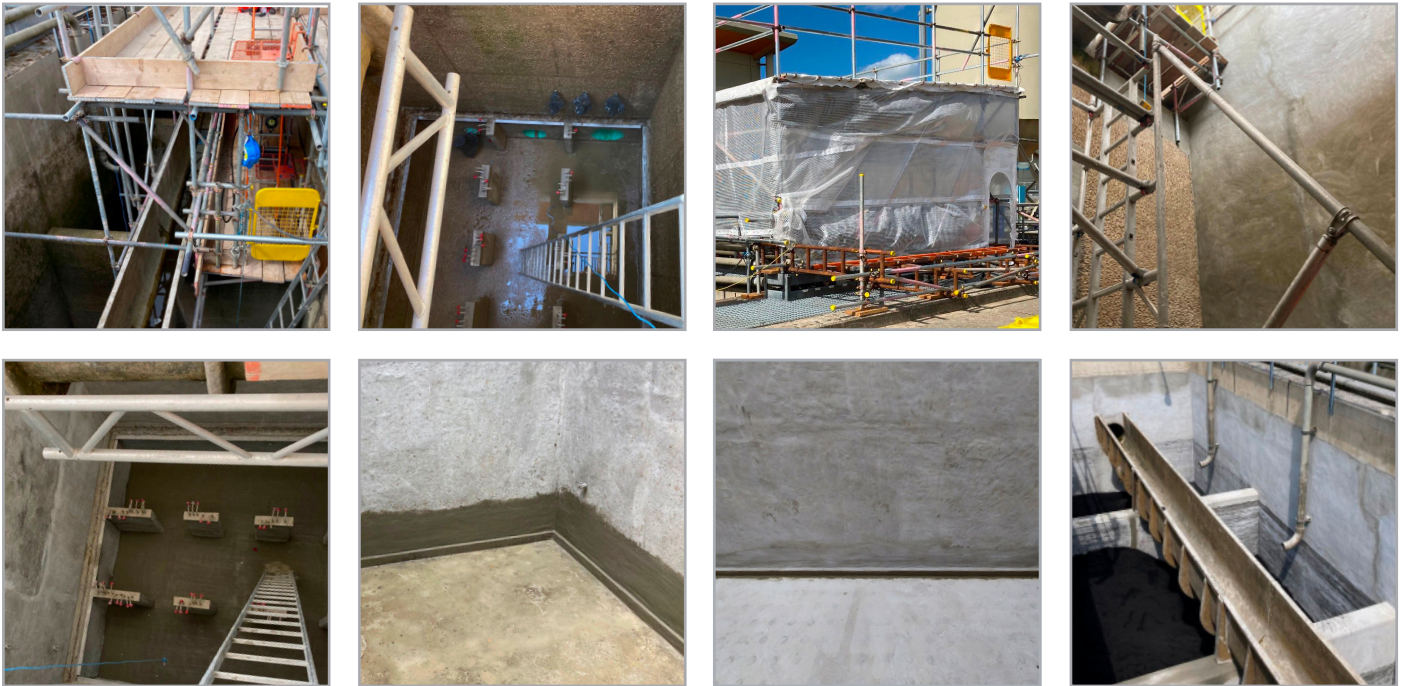
The two GAC tanks had become degraded over time due to the acidity of the water they hold and treatment chemicals present in it. Stonbury was enlisted to refurbish the assets and stop further degradation. Keir was the principal contractor for the project as the client had contracted them to complete further works to the site once the two tanks had been refurbished.

Working on one tank at a time, temporary scaffolding was erected to enable access inside the tanks to clean and remove laitance and loose concrete using high pressure water jetting. Scaffolding was then erected around the tank perimeter and shrink-wrapped to prevent ingress of water and keep the tank at a consistent temperature whilst the cementitious coatings were applied.

A Smooth-finish, waterproof render was applied to one cell at a time over a three-day period. All coatings were applied using hand towels and sponges to remove trowel lines and provide a clean finish. Pull-off tests were conducted after each application which demonstrated adequate adherence.

A second sub-contractor was appointed to complete concreting on the tank floors. The Stonbury team returned to complete the areas which were previously obscured by the access scaffolding and securely seal the area between the walls and the new concrete floors with a non-shrink grout. Finally, the team applied another layer of the waterproof render to provide a seamless finish.
