PROJECT STW ROOF REPLACEMENT

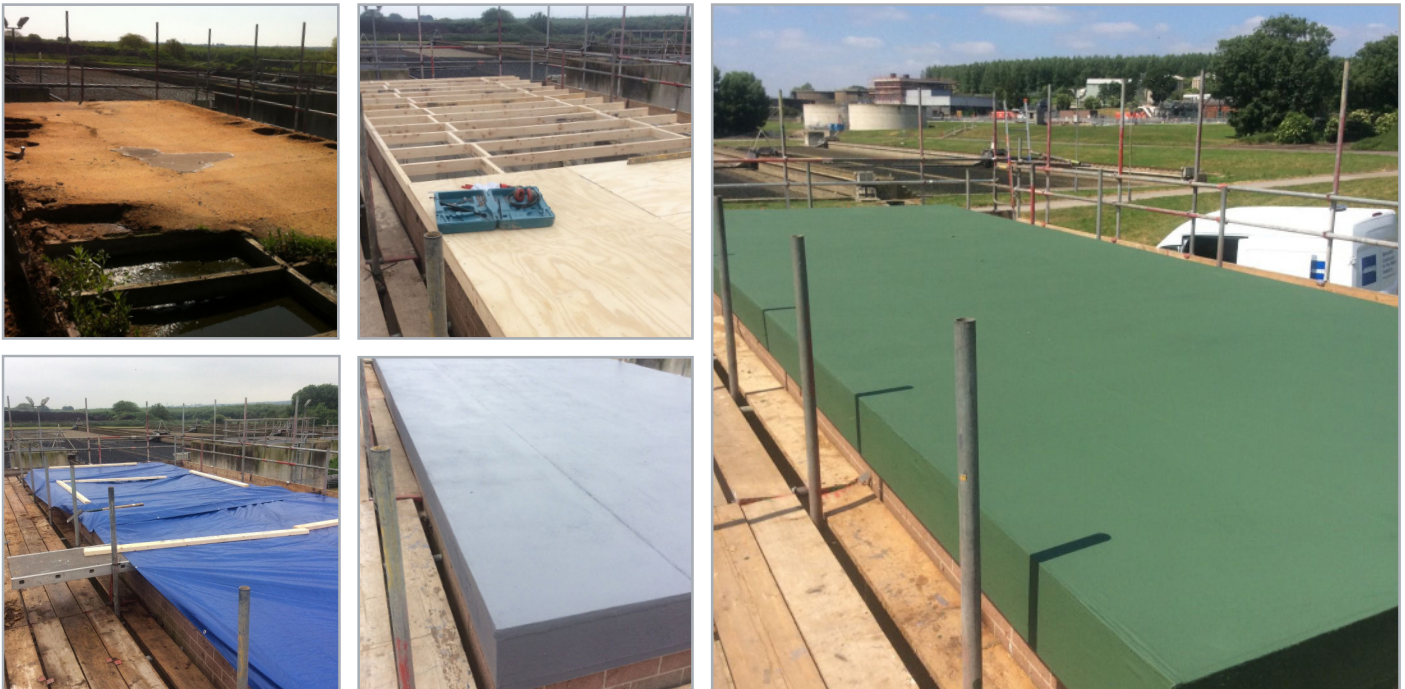
Once the works had been rescoped, scaffolding was erected to the full roof perimeter to allow safe access to the structure. The original roof was then completely removed due to rot, caused by the water ingress. The building was kept watertight during the removal to ensure the critical internal equipment was not damaged. A new roof structure was then constructed using timber and plywood.

Once the new base structure was complete, the new waterproofing system was installed. An epoxy roofing system was then applied to fully waterproof the building, this included a fiberglass reinforcing matting.

A primer coat was applied to the plywood to provide an initial seal, followed by the installation of 2no coats. The structure was completed with a final, green coat to minimise the impact of the building on the surrounding environment.
