PROJECT WATER TOWER ROOF REFURBISHMENT

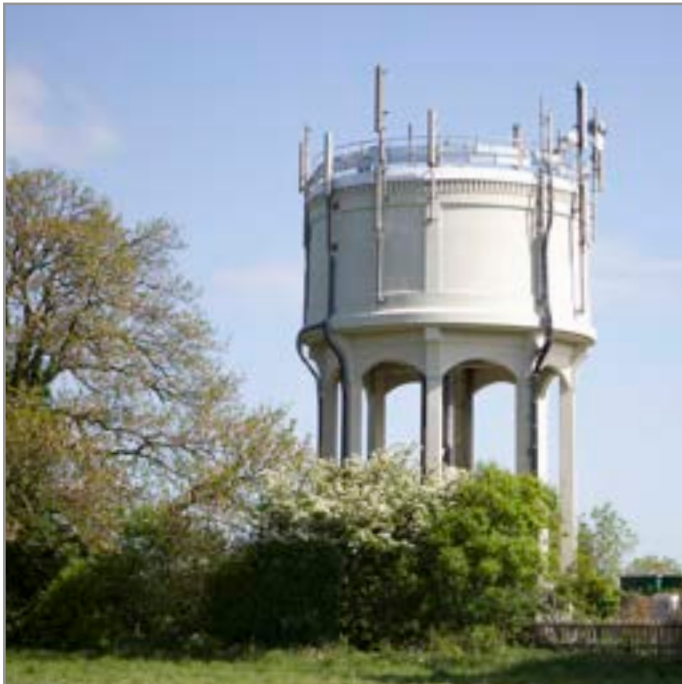
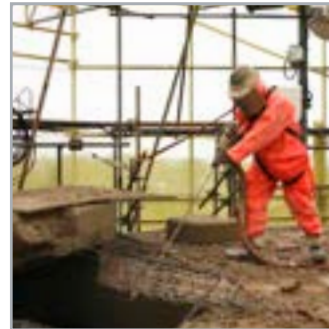
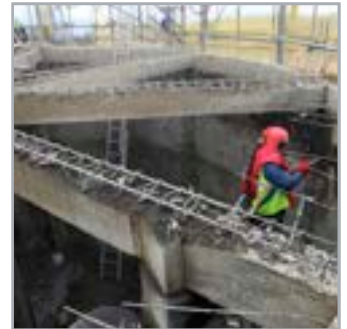
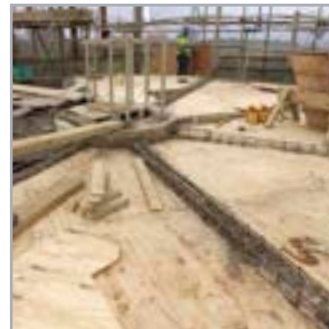
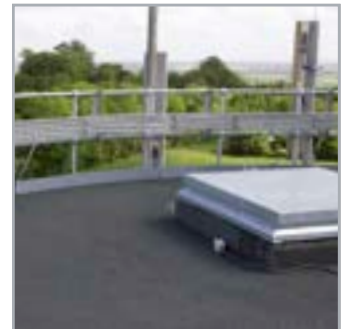
Previous attempts to carry out concrete repairs to the roof soffit highlighted that the roof slab was in deplorable condition, so the decision was made to replace it with new.

The existing concrete roof slab was demolished in sections, using ultra-high water jetting techniques. Once complete, a birdcage scaffold was erected internally, to support the timber shuttering and new steel reinforcement. To complete the soffit, concrete was pumped up to the roof to form the new, watertight slab.

removal of the existing bituminous asphalt liner, with the use of ultra-high water jetting techniques. Dry grit blasting was also used to remove the remaining bitumen primer from the concrete surfaces.

Concrete repairs were undertaken to re-level the walls and floor, prior to the application of a DWI approved waterproofing system and an elastomeric polyurethane coating.

Finally, the internal pipework was coated, the washout valves were replaced, and a new waterproofing system with a non-slip finish was applied to the roof, the new perimeter handrailing, access covers and internal stainless steel ladders.
